# **Calapooia Watershed Fish Passage Assessment**

**February 2004**

***BioSystems  
&  
Alsea Geospatial***

**For the  
The Calapooia Watershed Council**

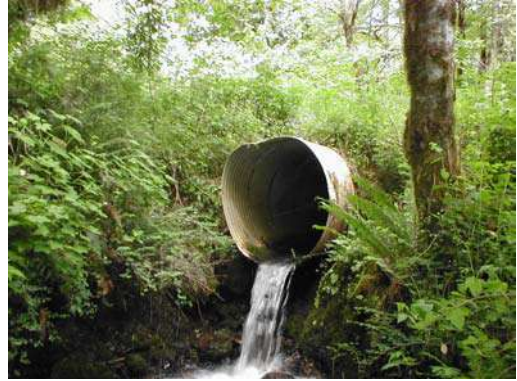
*Photo 1. Outlet drop from a culvert located in the headwaters of Brush Creek. This outlet drop is greater than the jumping ability of fish.*

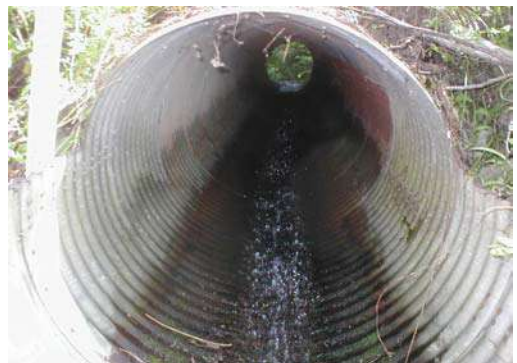
*Photo 2. The inlet to a culvert located in the headwaters of Courtney Creek. This culvert has a steep gradient (12%) and shallow water that prevent fish passage.*

Culverts commonly block fish passage by creating high water velocities within the culvert and creating a significant drop at their outlet. At the outlet of culverts, the stream bed is scoured, creating a pool (outlet pool) and a drop from the culvert (Photo 1). In addition, the slope of the culvert contributes significantly to increasing stream velocities, often producing currents greater than a fish's ability to swim (Photo 2).

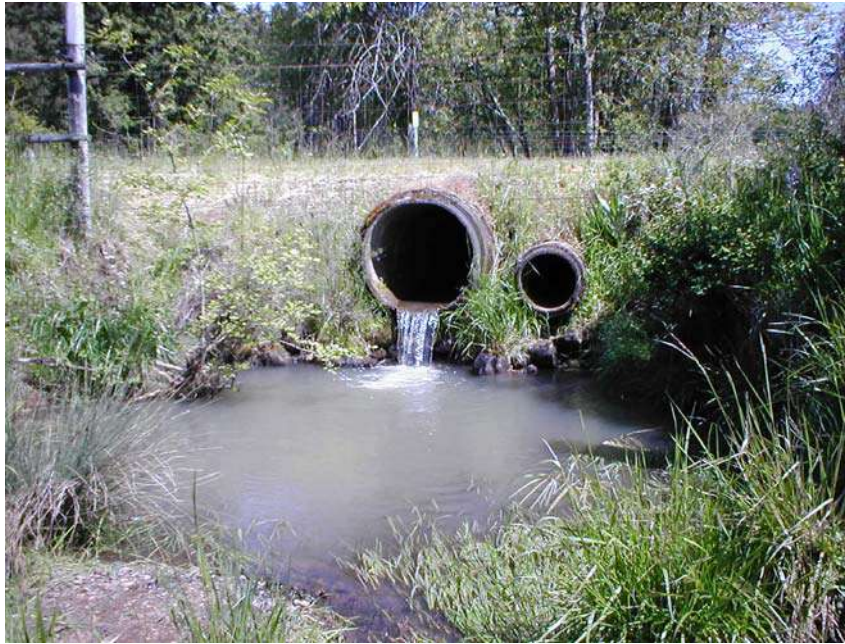
*Photo 6. Culvert 203, located where Crawfordsville Drive crosses an unnamed tributary that flows directly into the Calapooia River from the north. This is an example of a highest priority culvert: stream gradient is 1.5%, bankfull width is 14 feet, jump height is ~1.5 feet, and culvert gradient is 1.0%.*

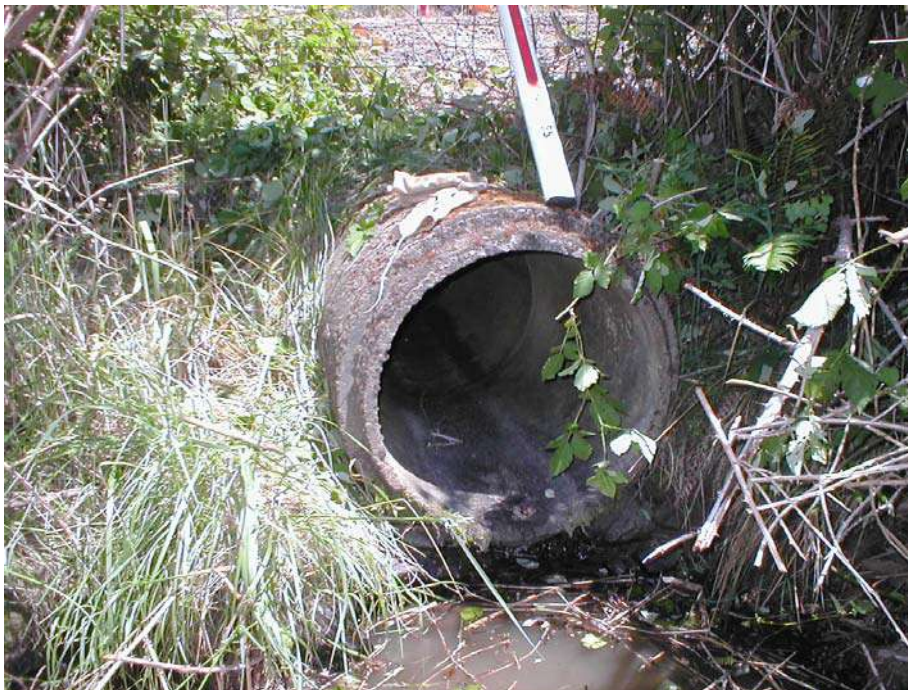
*Photo 7. Culvert 54, located where Northern Drive crosses a tributary to the Calapooia River from the north. This is an example of a high priority culvert: stream gradient is 0.7%, bankfull width is 7 feet, jump height is 0.7 feet, and culvert gradient is 3.1%.*

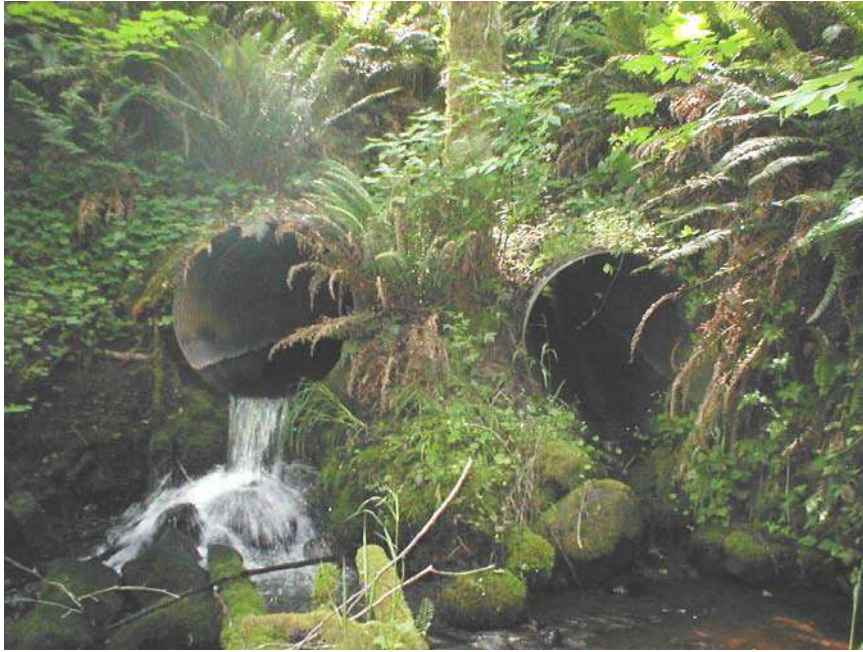
*Photo 8. Culvert 412, located in the headwaters of the West Fork Brush Creek. This is an example of a medium priority culvert: the jump height into the outlet (~1.5 feet, culvert gradient is 9.6%, and the drop onto rock for these two culverts would not allow for fish passage, but the location of the crossing in a high gradient part of the watershed (5% stream channel gradient) gives it a lower priority than culverts located in low gradient (4% or less) streams.*

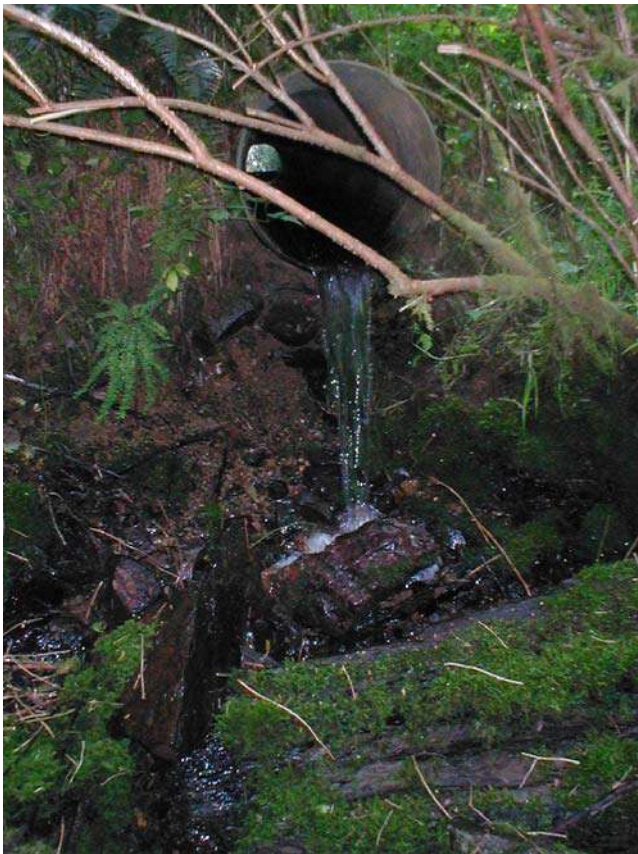
*Photo 9. Crossing 382-482, located on a headwater tributary stream to Courtney Creek. This is a low priority culvert: the stream gradient (11%) is very steep and this is probably not a part of the stream used by fish.*

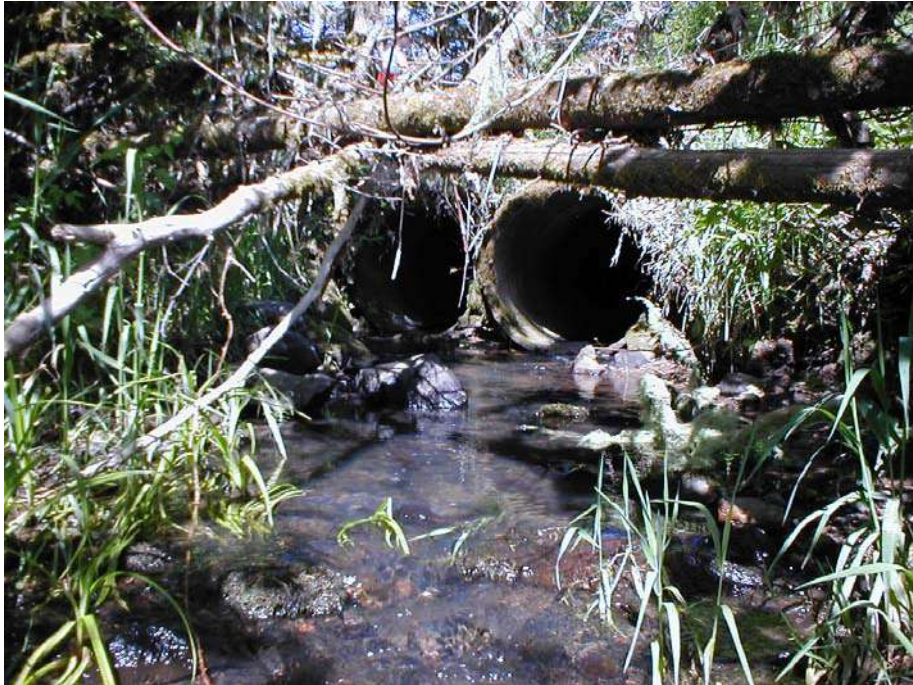
*Photo 10. Culvert 12, located on a tributary to Johnson Creek. This is an example of crossing with multiple culverts that both meet ODFW criteria with a culvert gradient of less than 0.5% and a jump height into the culvert of less than 6 inches.*

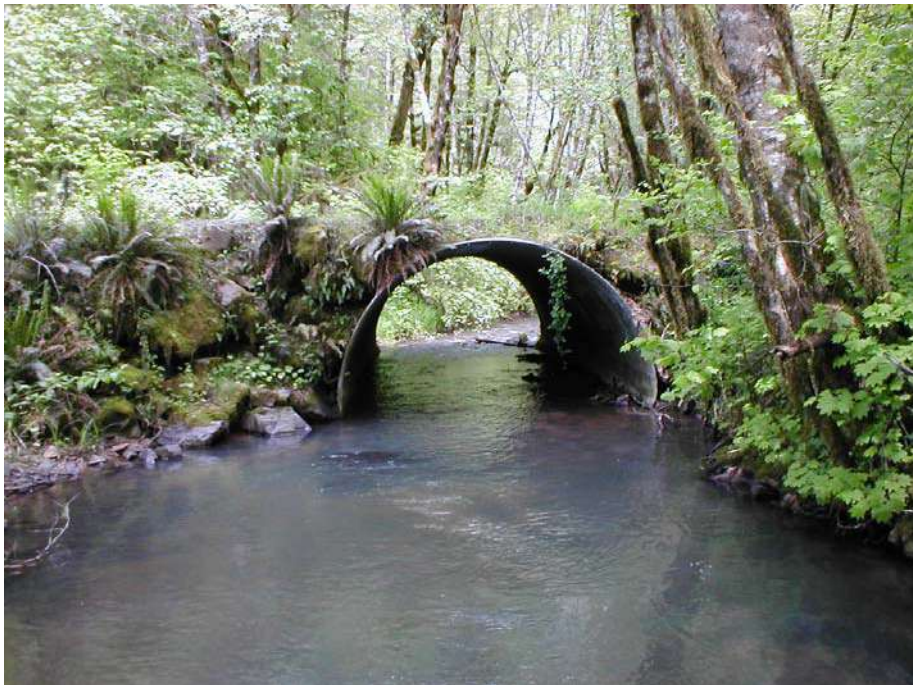
*Photo 11. Culvert 323, located on the west fork of Brush Creek. This embedded culvert is an excellent example of a culvert designed to pass juvenile and adult fish. There is no outlet drop and the culvert gradient is the same as the stream channel gradient.*
