# Calapooia River - Albany Assessment and Project Implementation Plan

## Final Report

*Site Assessment on the Willamette River.*

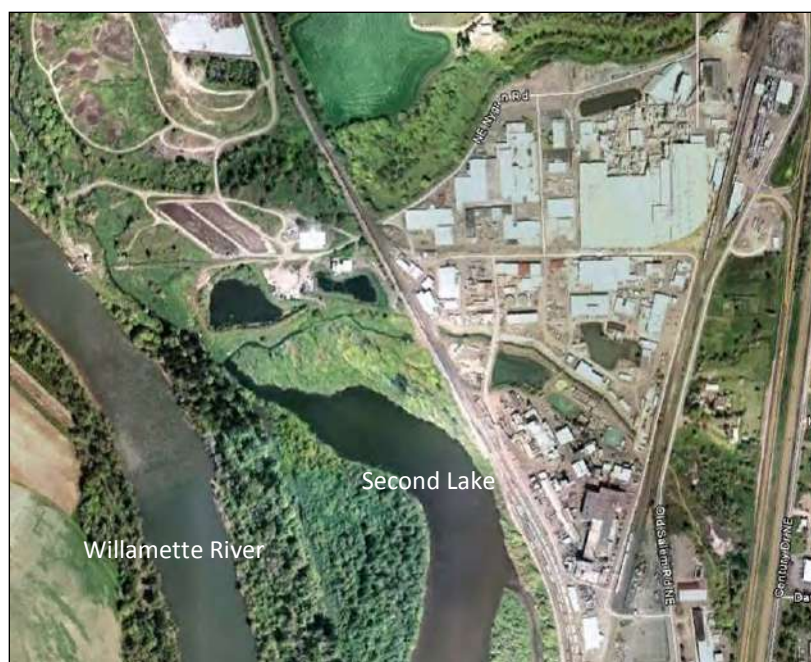
**Figure 3-2.** The industrialized eastern floodplain of the Willamette River. Industrial development has influenced tributary streams and the oxbow lakes located north of Albany.

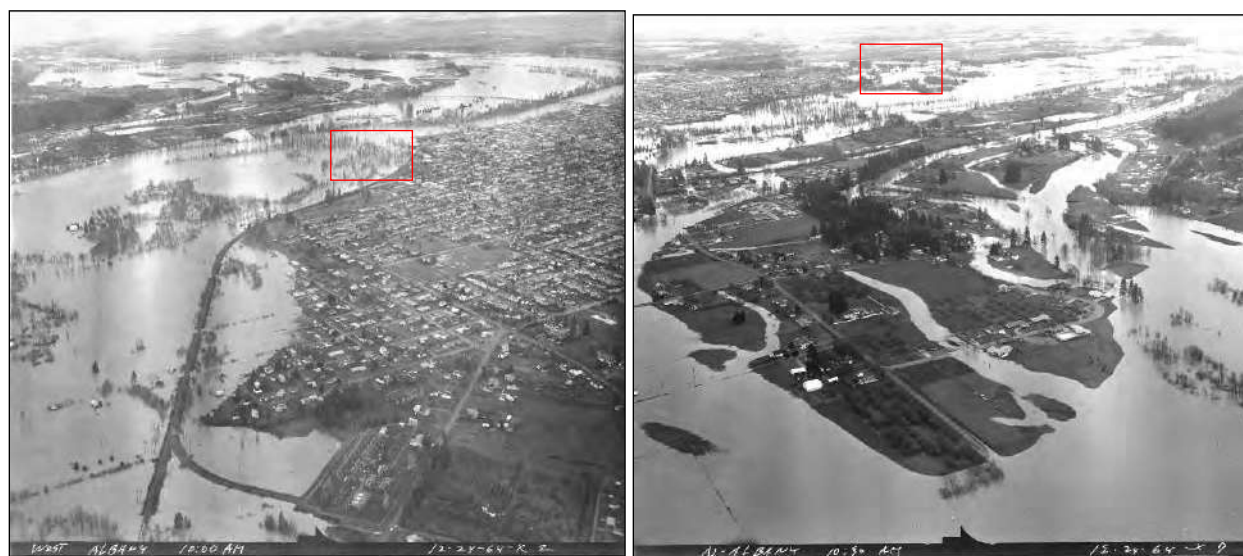
**Figure 3-4.** Views of the December 24, 1964 flood including a view to the northwest including the confluence of the Calapooia River and the Willamette River (left, in red box) and a view to the southeast from North Albany towards the Calapooia River confluence (right, in red box). Thornton Lake is in the middle of the photo. Photos courtesy of the City of Albany.

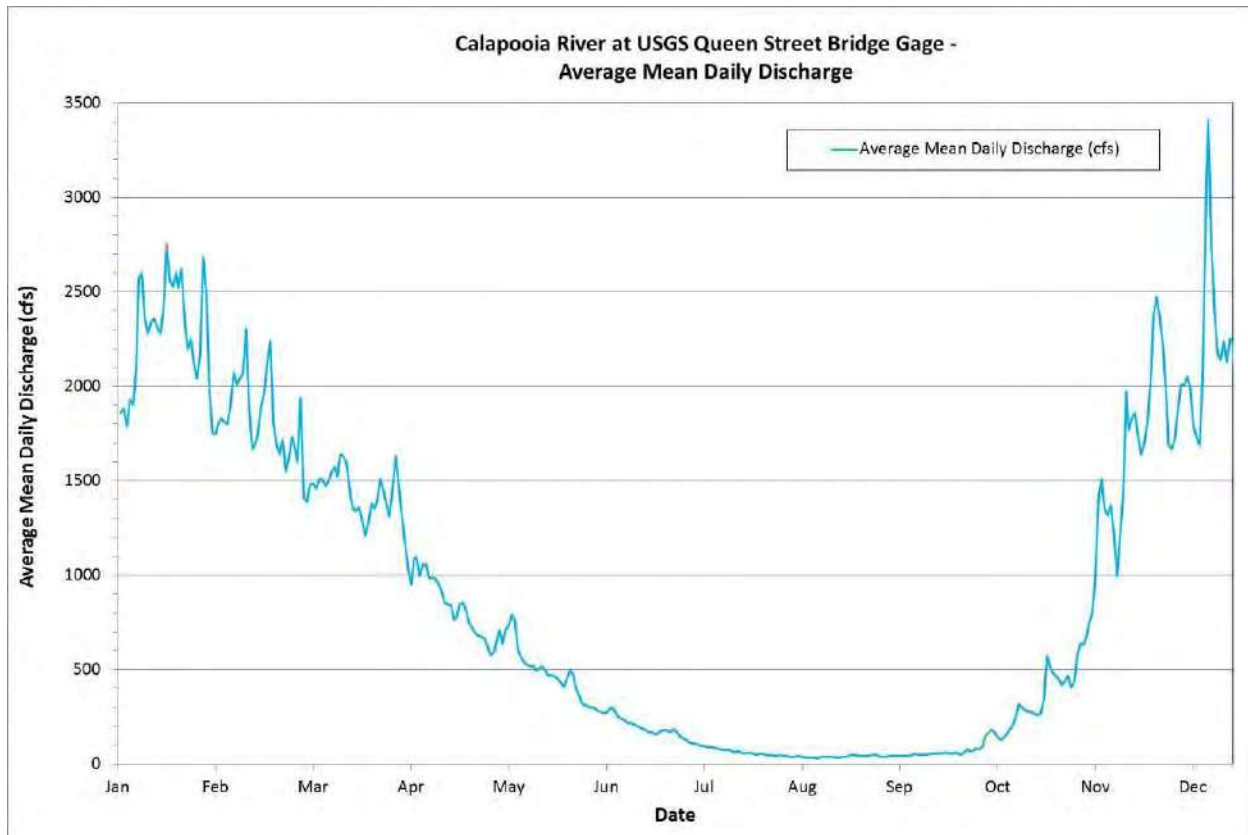
**Figure 3-7.** Average mean daily discharge for the Calapooia River measured at the former USGS gage station at SW Queen Avenue Bridge. The graph illustrates the large difference between low summer time flows and winter and spring high flows. The average mean daily discharge calculations are based on the 41 year period of record (1941 to 1981).

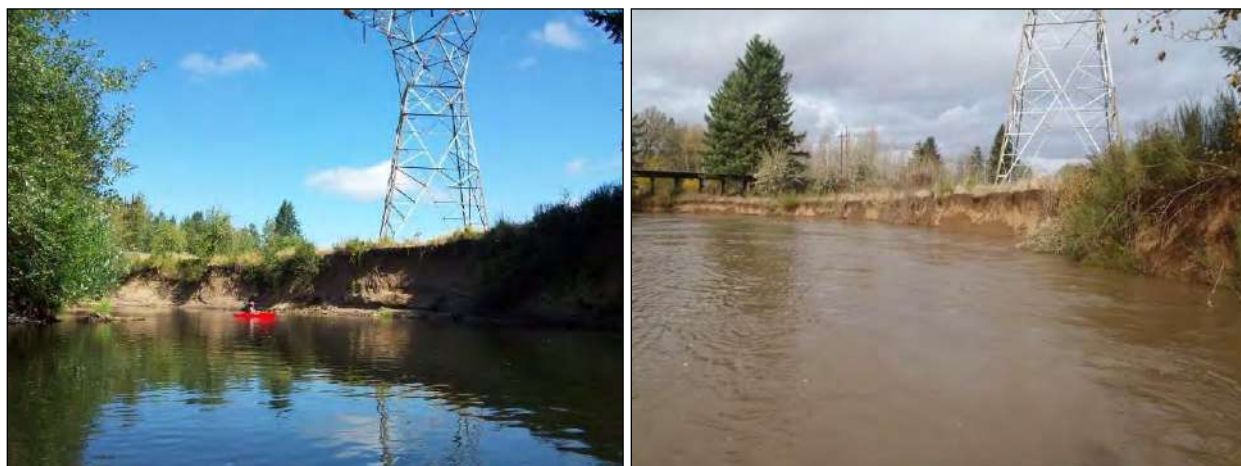
**Figure 3-9.** A comparison of river conditions associated with low (left) and moderate (right) flows on the Calapooia River downstream from SW Queen Avenue Bridge. The height of the eroding bank is masked by moderate flows but the magnitude was apparent during the summer field data collection.

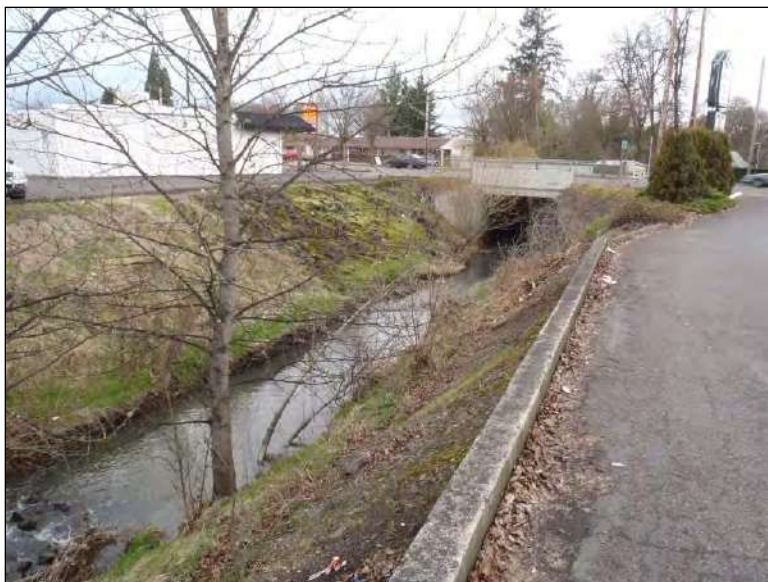
**Figure 3-10.** Periwinkle Creek downstream from the SE 9<sup>th</sup> Avenue Bridge. This reach marks the start of the more urbanized reach of Periwinkle Creek. The riparian zone has been narrowed to a fringe and impervious surfaces such as roads and parking lots accelerate stormwater discharge to the creek. Stream corridor modifications have allowed development to expand to the stream edge while protecting against flooding.

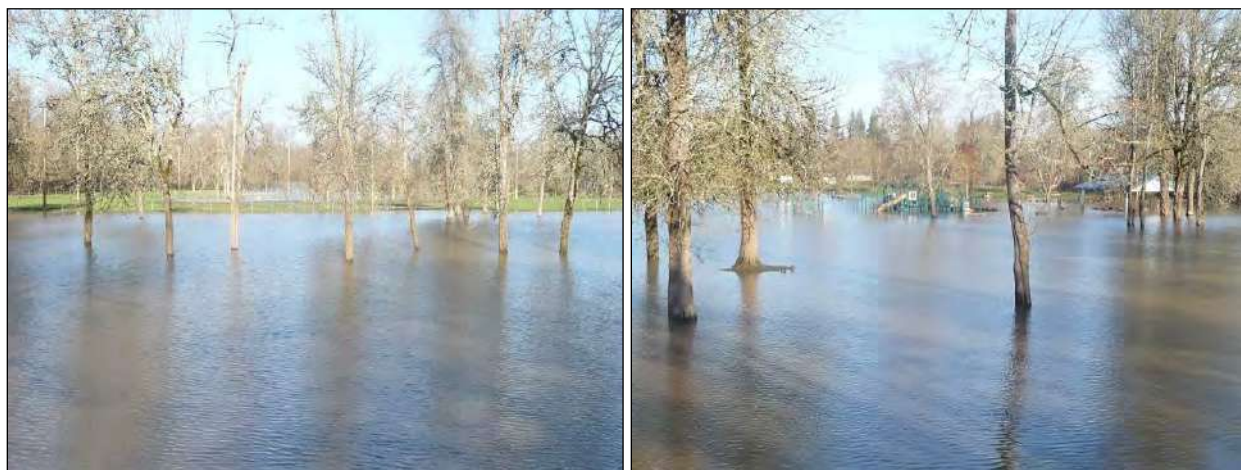
**Figure 4-4.** Views of Bryant Park from December 31, 2010 showing inundation from the Calapooia River.

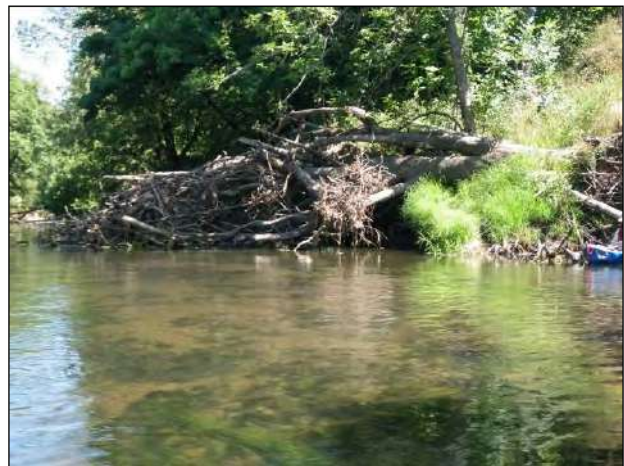
**Figure 4-5.** A large wood aggregation on the lower Calapooia River. Aggregations accumulate smaller debris over time but may also mobilize during higher magnitude runoff events.

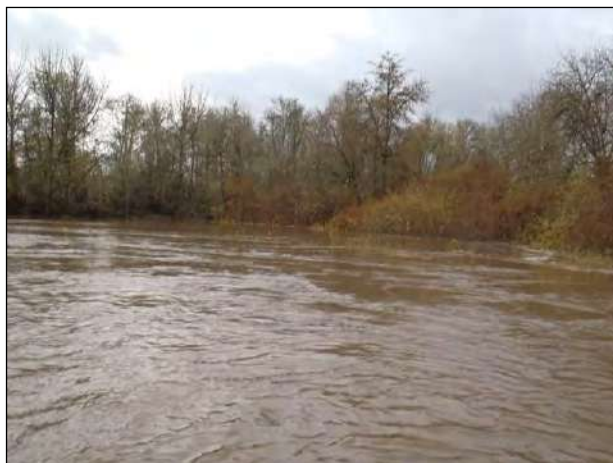
**Figure 4-6.** A low velocity channel margin area marks the confluence of a floodplain side channel with the Calapooia River. These areas provide refuge for fish during high water events.

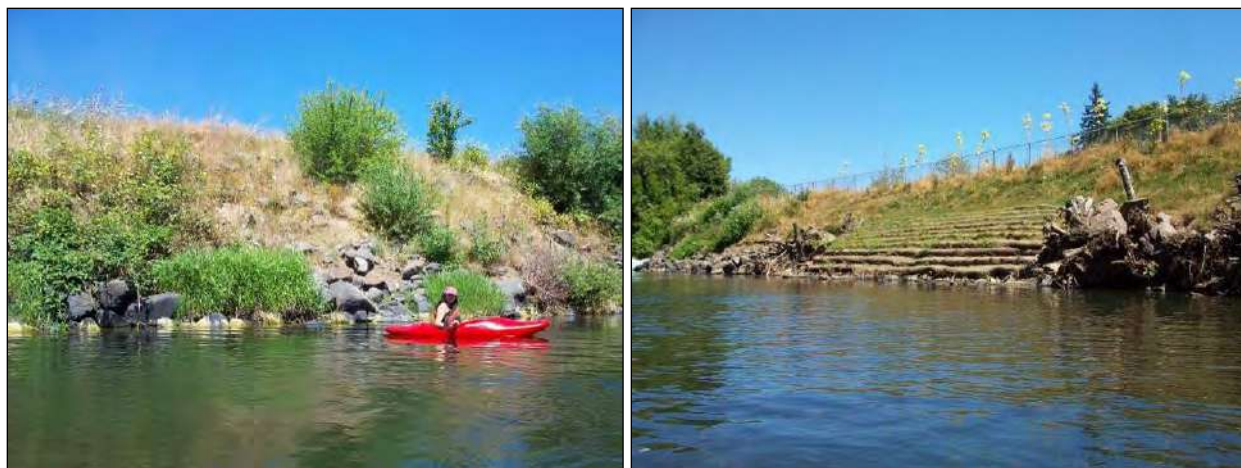
**Figure 4-7.** Two examples of bank stabilization treatments in the assessment reach. The left photo shows older rock riprap and a revegetating streambank at STA 85+00. Bioengineering and large wood structures were used to stabilize an eroding bank adjacent to City of Albany settling ponds at STA 32+00.

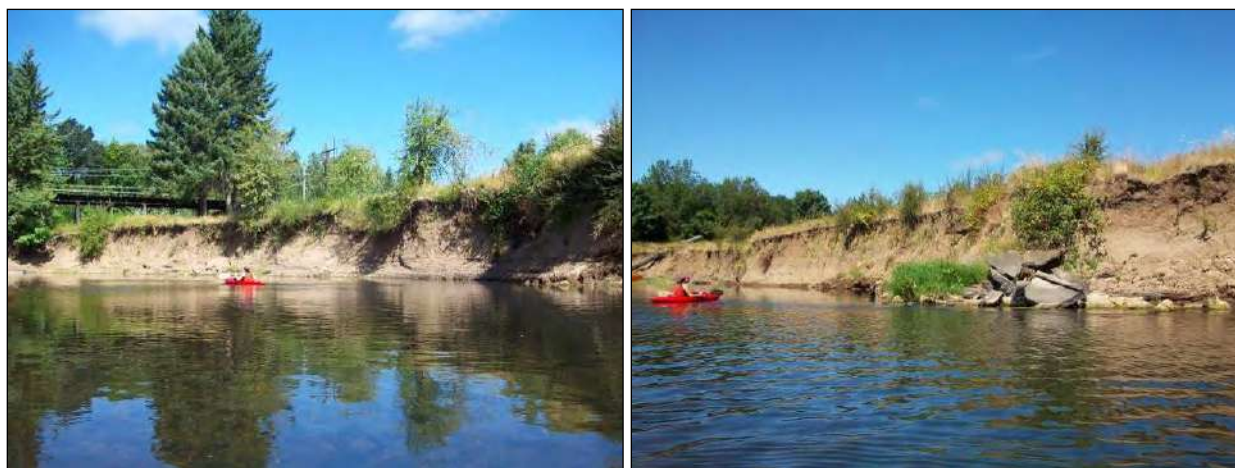
**Figure 4-8.** Eroding bank sites E1 (left) and E3 (right). Both sites are actively retreating as the river laterally migrates. The vertical banks, fine bank materials, and poor vegetation conditions increase the streambank erosion potential.

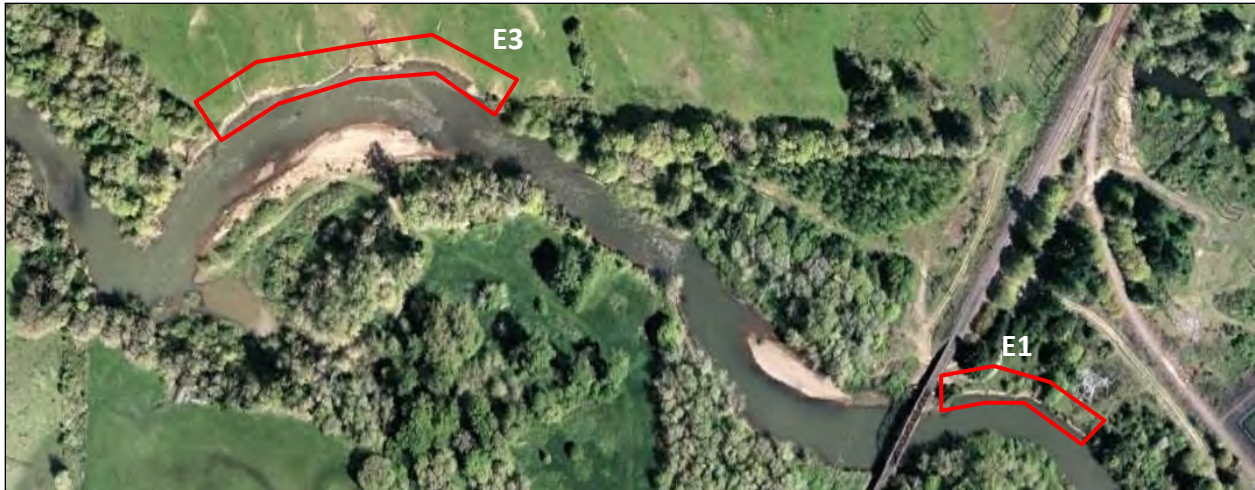
**Figure 4-9.** The location of E1 and E3 on the Calapooia River. Both sites are located on outside bends. The river is migrating down-valley at E3. Vegetation removal at both sites for power line protection, is likely influencing channel stability.

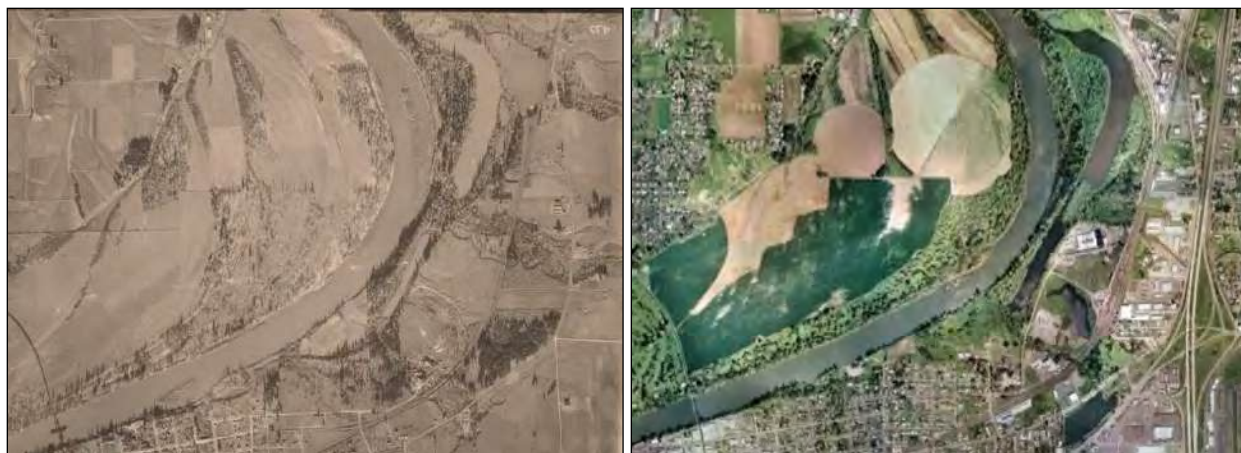
**Figure 4-11.** A comparison of riparian conditions in the 1936 (left) and 2006 (right) air photos. Primary riparian corridor changes include conversion of the native riparian forest to agricultural land on the western floodplain, and the development of the eastern floodplain north of the City of Albany for industrial uses.

The 1936 and 2009 air photos were also used to evaluate the riparian corridor bordering the Willamette River to assess how the corridor has changed over time in light of agricultural development and City of Albany growth. Figure 4-11 and 4-12 include representative comparisons of the riparian zone, floodplain habitats, and in-channel complexity in the Willamette River. General observations include:

- Historical riparian forests have been narrowed for agricultural development and rural residential and urban expansion.
- Floodplain depressions and wetlands have been converted for agriculture.
- The Willamette River has narrowed and simplified in response to flood control operations, other watershed changes (e.g. wood removal from tributary rivers), and local river modifications such as bank armoring.

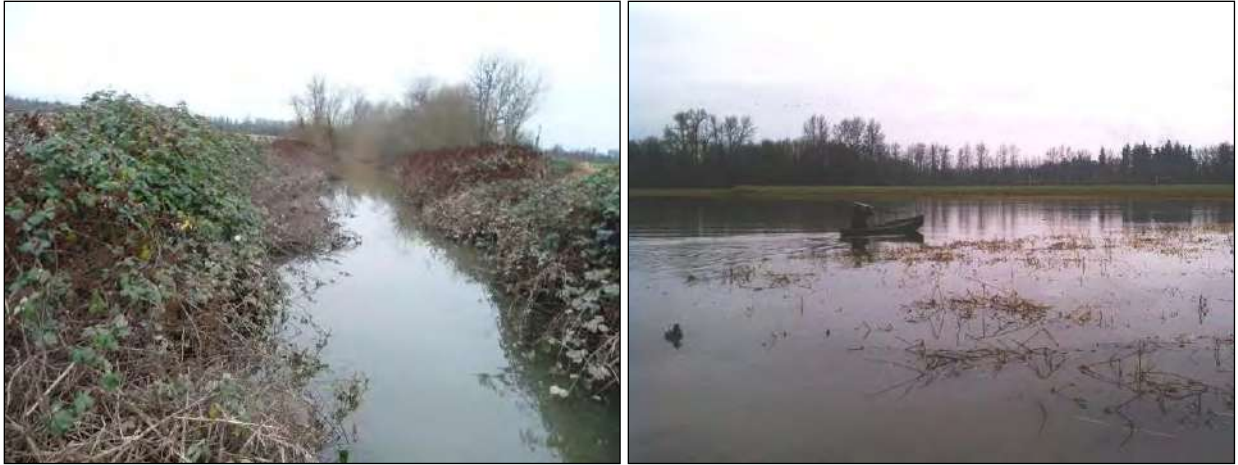
**Figure 4-14.** An example of a floodplain slough at 16,000 cfs (7.78 ft stage) at the Willamette River Albany gage (left) shows the slough before widespread floodplain inundation on January 7, 2011. At 26,000 cfs (11.2 ft stage) at the Willamette River Albany gage on January 28, 2011, the floodplain is widely inundated due to the backwatering of the floodplain slough (right).

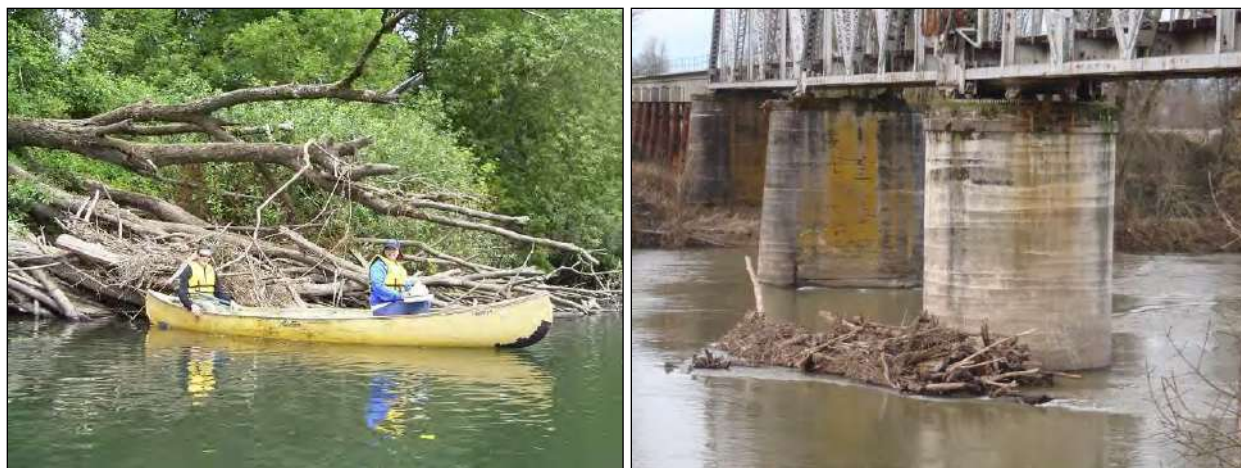
**Figure 4-15.** Large wood accumulations on the Willamette River provide channel margin complexity and habitat (left). Wood and debris transported by the Willamette River often accumulates on bridge abutments, such as this private railroad bridge, located in the assessment reach (right).

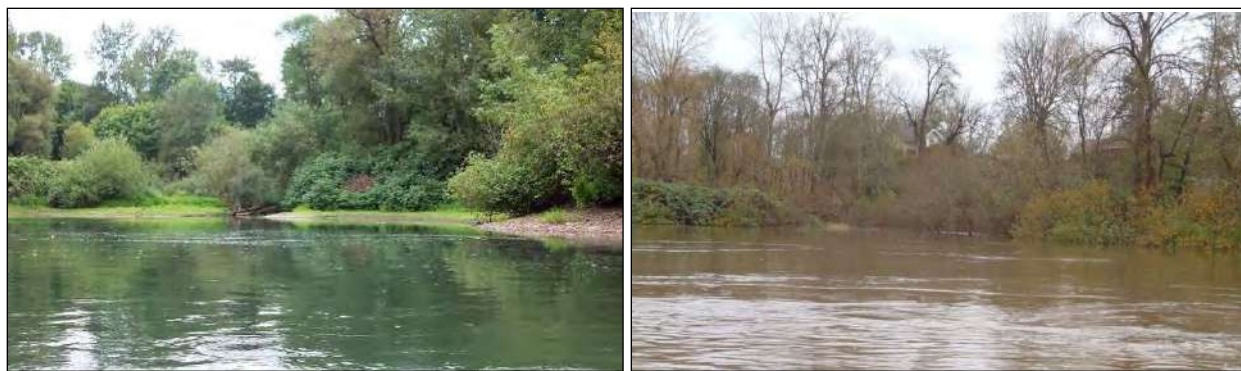
**Figure 4-16.** The mouth of Periwinkle Creek during summer base flows (left) and typical winter flows (right). The Periwinkle Creek confluence provides shallow, low velocity habitat year round.

These features vary in size and degree of connectivity with the Willamette River. In general, side channel, channel margin, and alcove habitat areas increase in size with increasing river stage. Figure 4-16 includes a comparison of the Periwinkle Creek confluence in July and December. Juvenile Chinook salmon and steelhead were sampled from the confluence area during the ODFW and City of Albany sampling in 2001 and 2002. Juvenile and adult fish likely use these lower velocity areas during winter and spring high flows.

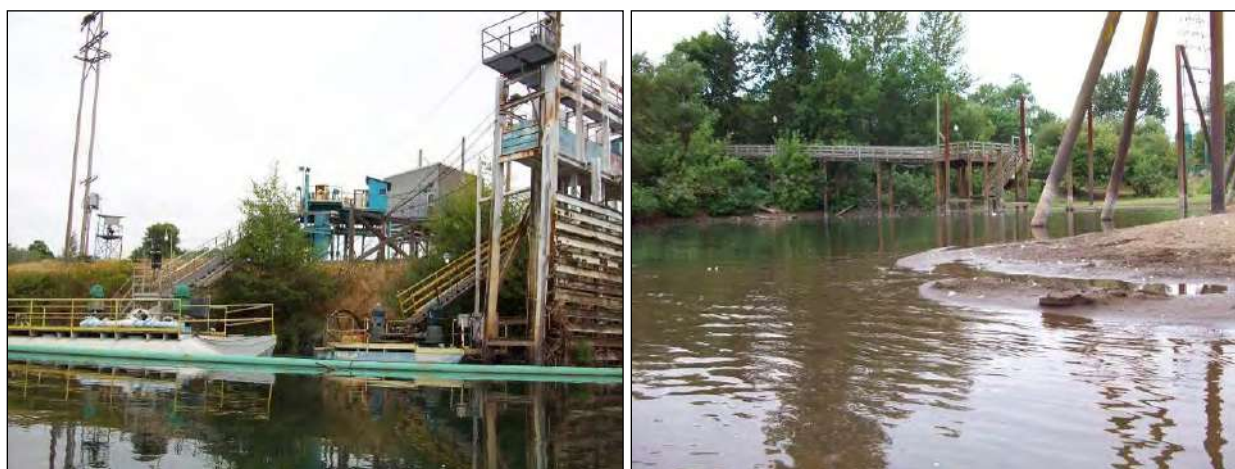
**Figure 4-17.** The pump station on the Willamette River supplies water to the ATI-Wah Chang facility (left). Pilings protect the City of Albany pier on the Willamette River downstream from the Calapooia River confluence.

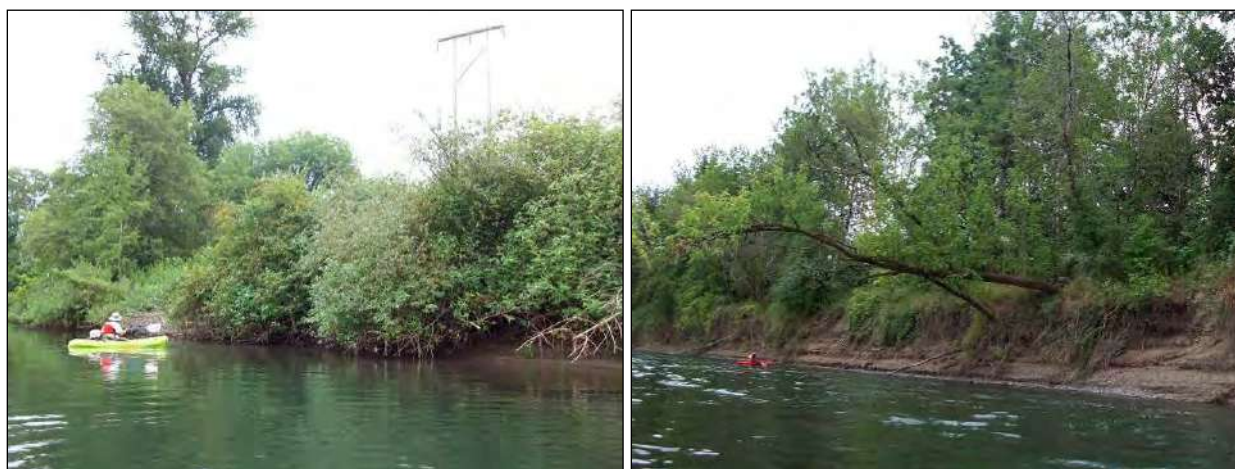
**Figure 4-18.** Example streambank conditions in the Willamette River reach. Stable banks were typified by lower gradient bank slopes, lower bank heights, and dense riparian vegetation (left). Unstable banks had steeper bank slopes, were higher, and often had comparatively poor riparian vegetation conditions

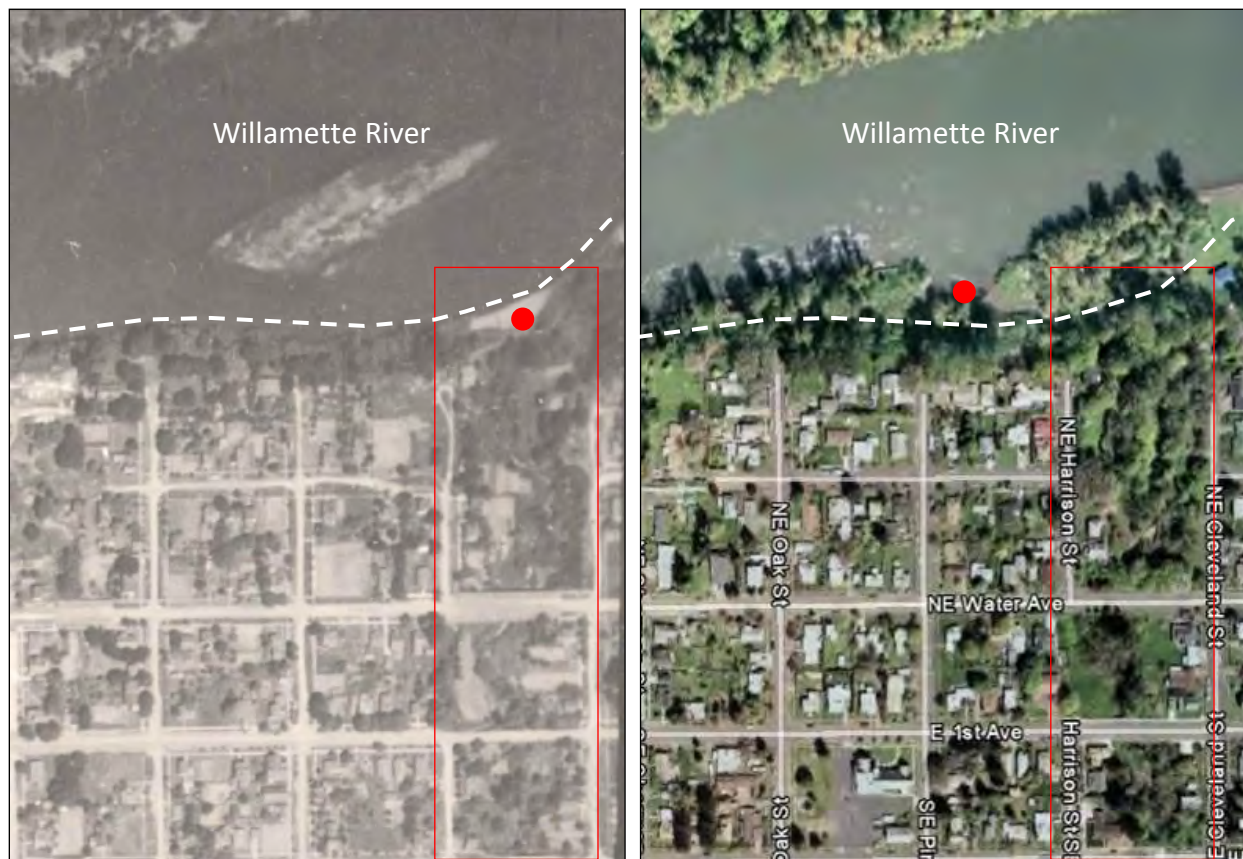
**Figure 4-20.** A comparison of the 1936 (left) and 2006 (right) air photos of lower Periwinkle Creek. The photos are approximately the same scale and perspective. The red box surrounds the creek in both photos. An island was formerly located mid-channel in the Willamette River across from the Periwinkle Creek confluence. An area that was formerly inundated by the Willamette River, is now floodplain marking the mouth of Periwinkle Creek and the western extent of Bowman Park. The white hatched line shows the 1936 shoreline overlaid on both photos. The red dot represents the Periwinkle Creek confluence.

The Willamette River in the vicinity of the Periwinkle Creek confluence changed considerably from 1936 to 2006. Figure 4-20 includes an air photo from the two periods. The 1936 river was wider with a mid-channel bar that created a narrow channel between the island and river-right bank. The mouth of Periwinkle Creek had a narrow riparian zone and the creek's delta appeared to be due north of the main creek alignment.

The contemporary Willamette River lacks the mid-channel island seen in the 1936 photo. The river appears to have narrowed through the reach primarily by filling at the mouth of Periwinkle Creek. The deltaic deposit is now vegetated by a cottonwood overstory and willow understory. The encroachment of the Periwinkle Creek delta may be the result of the Willamette River's reduced sediment transport capacity related to flood control operations. The rapid urbanization of the Periwinkle Creek watershed may have also caused channel incision and subsequent sediment deposition at the creek's mouth. A combination of these processes may account for the expanded floodplain at the Periwinkle Creek confluence.

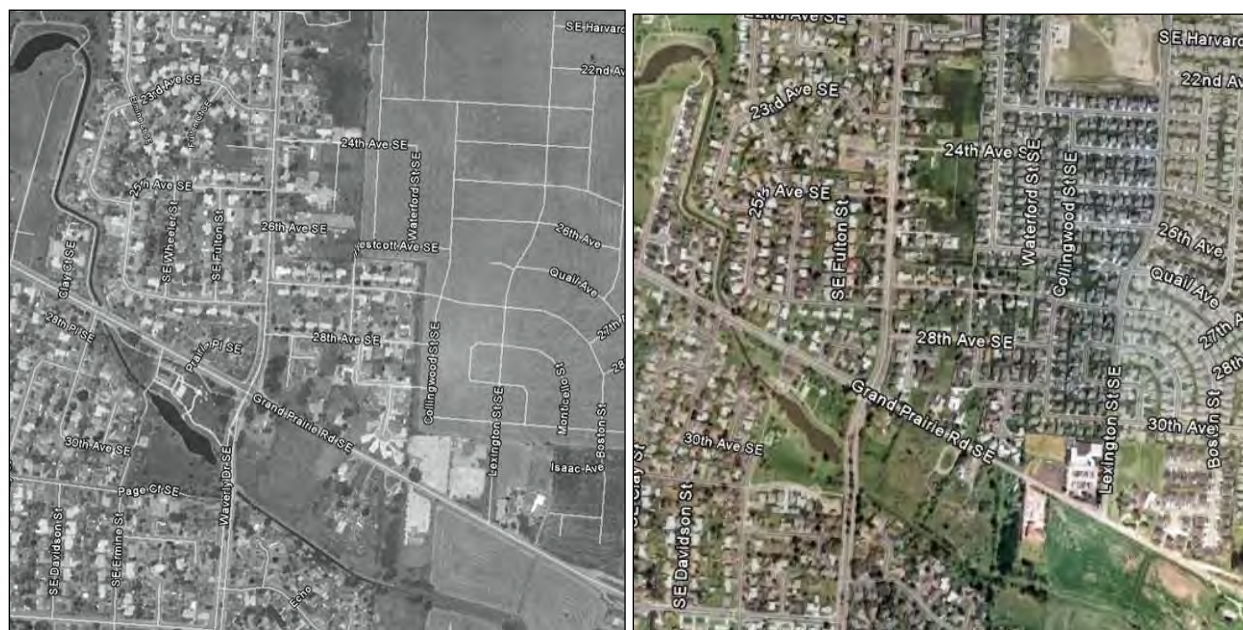
**Figure 4-21.** A comparison of more recent air photos shows the increasing density of development in the middle Periwinkle Creek watershed. The two air photos from 1994 (left) and 2006 (right) highlight the stream corridor modifications that have occurred on Periwinkle Creek. Infill development that occurred over the 12 years covered by the air photos increased impervious surface area and stormwater discharge.

The rapid population growth of the City of Albany since the 1990s typifies urbanization in the Willamette Valley, with displacement of agricultural land for housing developments. Figure 4-21 presents a comparison of the middle Periwinkle Creek watershed in 1994 and 2006. Former agricultural land north of Grand Prairie Road SE was converted to housing developments over an approximate 10 year period. The developments and road network convey stormwater to the artificial section of Periwinkle Creek.

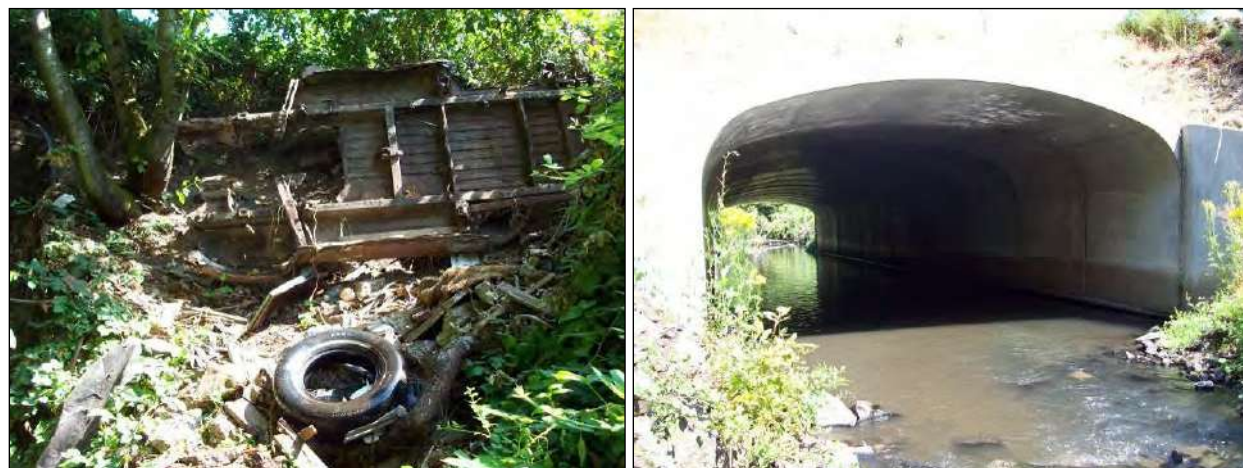
**Figure 4-24.** Debris such as old car bodies was used in the past for bank stabilization treatments (left). A concrete arch at SE 2<sup>nd</sup> Avenue provides fish passage (right).

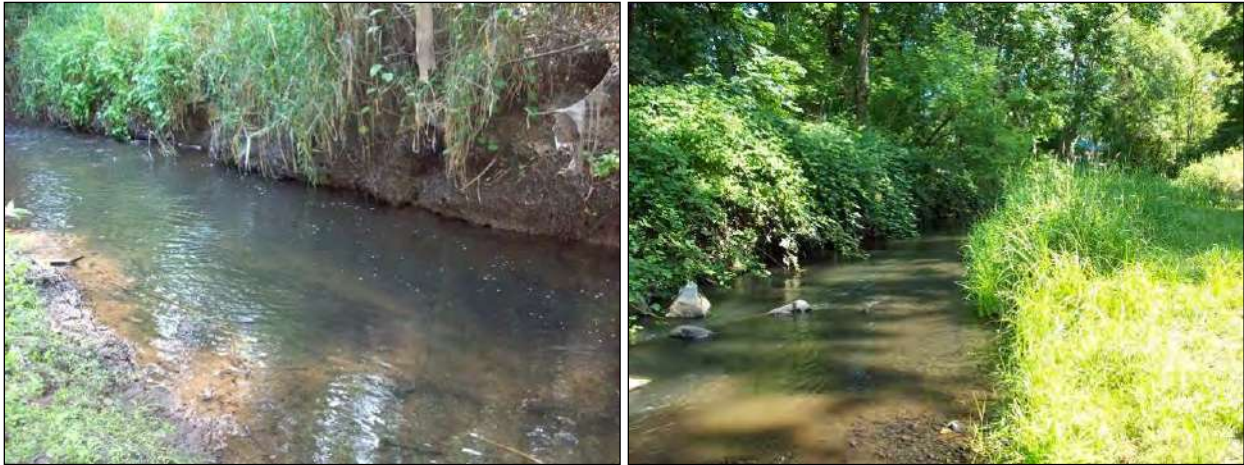
**Figure 4-25.** Example streambank erosion sites on lower Periwinkle Creek. The left photo is site E6, a river-left eroding site at STA 8+00. The right photo is from the E4 site located at STA 12+00. The river-left toe of the bank has been scoured.

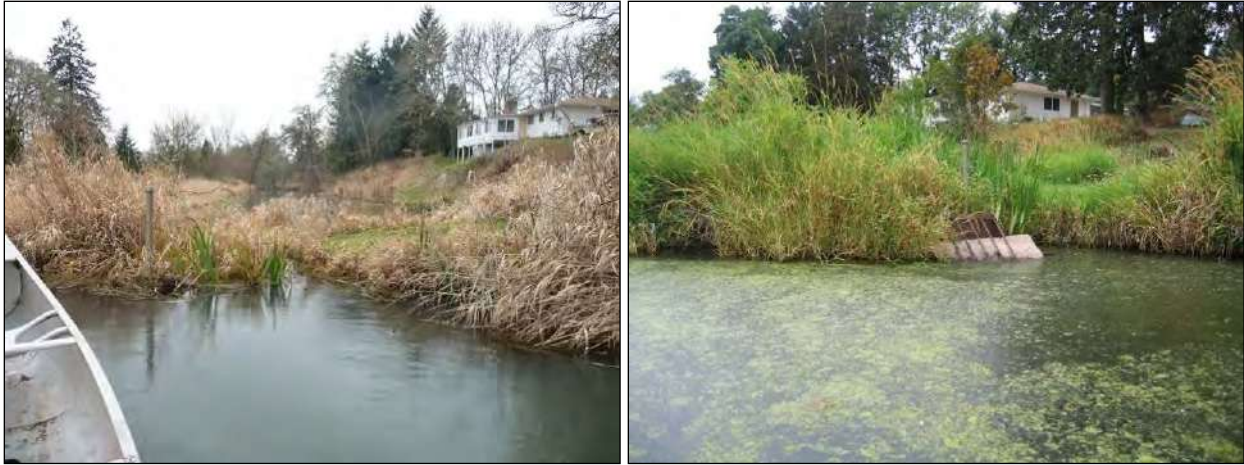
**Figure 4-29.** The outlet at West Thornton Lake at moderate flows in January 2011 when the natural outlet was overtopped (left) and during summer conditions when the lake level is below the outlet elevation (right). A board is placed in the culvert inlet to block outflow from the lake. The culvert allows for drawing down the lake an additional 1-2 ft below the outlet.

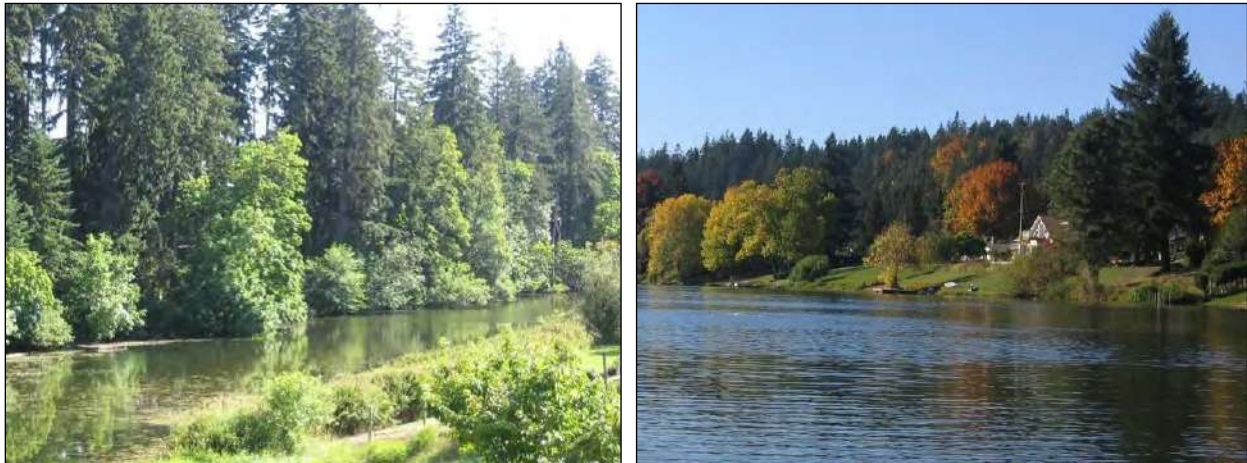
**Figure 4-30.** Example habitat conditions from the East Thornton Lake Natural Area (left) and the north shore of West Thornton Lake (right). Much of the riparian zone around East Thornton Lake remains intact. West Thornton Lake has experienced more residential development and riparian conditions are more variable. Photos courtesy of FETL.

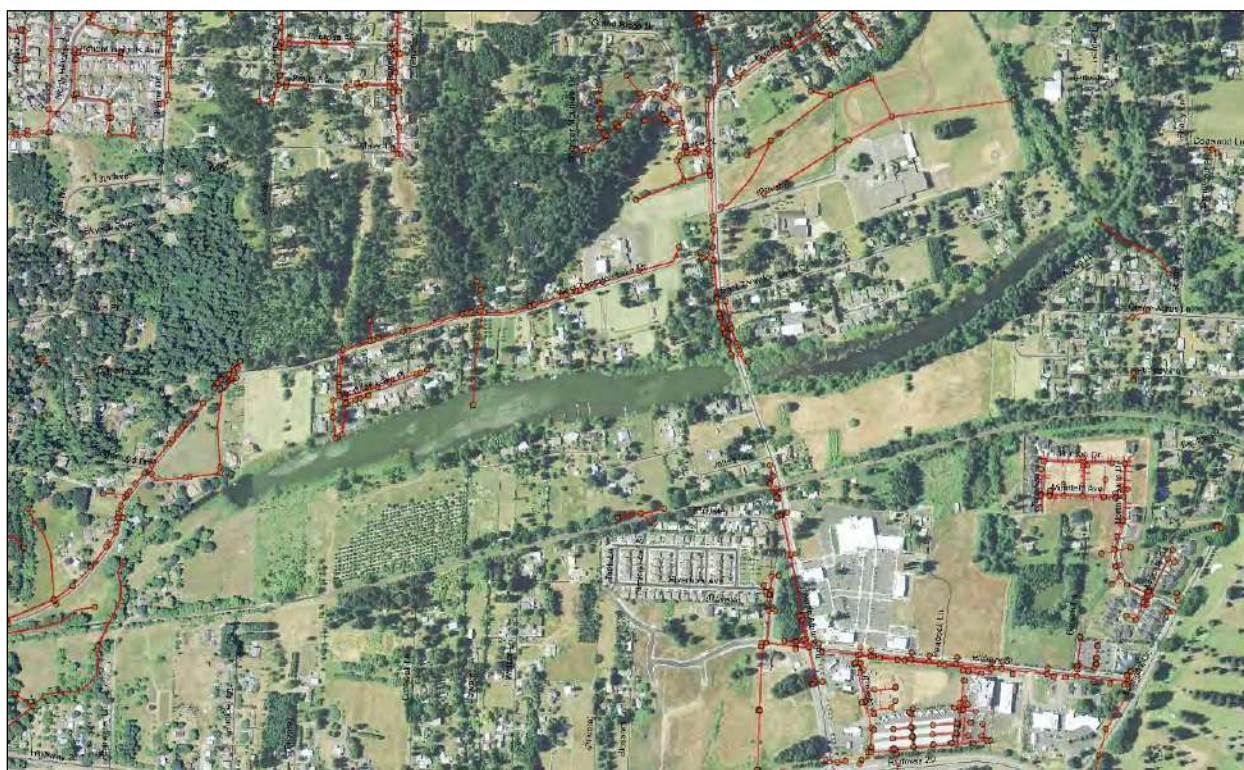
**Figure 4-31.** The 2009 air photo covering Thornton Lake. The stormwater GIS layer is included to show the location and extent of stormwater infrastructure (data courtesy of City of Albany GIS).

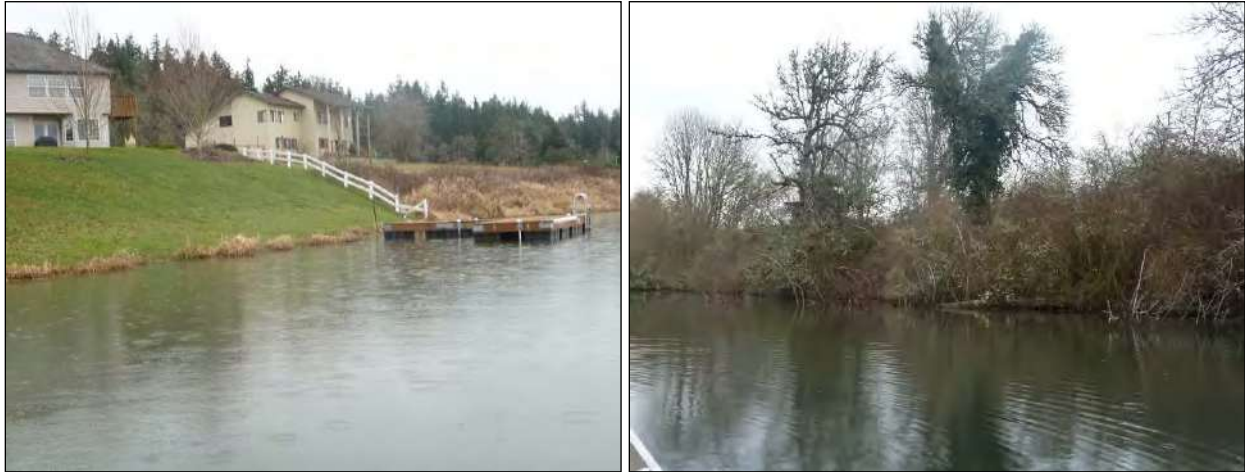
**Figure 4-32.** A comparison of three lake front vegetation conditions on Thornton Lake. The left photo includes a side by side comparison of a lawn extending to the lake edge next to a property that has a reed canarygrass and spirea buffer. The right photo shows the diverse habitat conditions along the ETLNA. While most of the vegetation along the natural area is native, invasive blackberry and ivy have encroached on the riparian zone. The tree in the middle of the photo has been colonized by ivy which will eventually kill the tree if not treated. FETL is currently preparing a vegetation management plan for ETLNA.

Bank erosion was minimal on Thornton Lake due to the low energy environment. Rather than focus on bank erosion, we noted lake frontage vegetation conditions. Maintaining a riparian buffer between upland land uses and the lake is important for sequestering sediment, nutrient, and pollutant runoff, and for providing aquatic and riparian habitat. Table 4-14 included a summary of lake front habitat conditions. Example photos are included in Figure 4-32. Typical beneficial conditions included a riparian shrub buffer comprised of willows, dogwood, and spirea thickets. Conversely, managed landscapes included manicured lawns extending to the

lake edge. An intermediate condition was defined by reed canarygrass (often including spirea) which provides a buffer between upland runoff and the lake, but lacks the habitat characteristics attributed to plant communities dominated by native shrubs. Working with landowners to maintain appropriate riparian buffers would potentially improve water quality and enhance shoreline habitat.

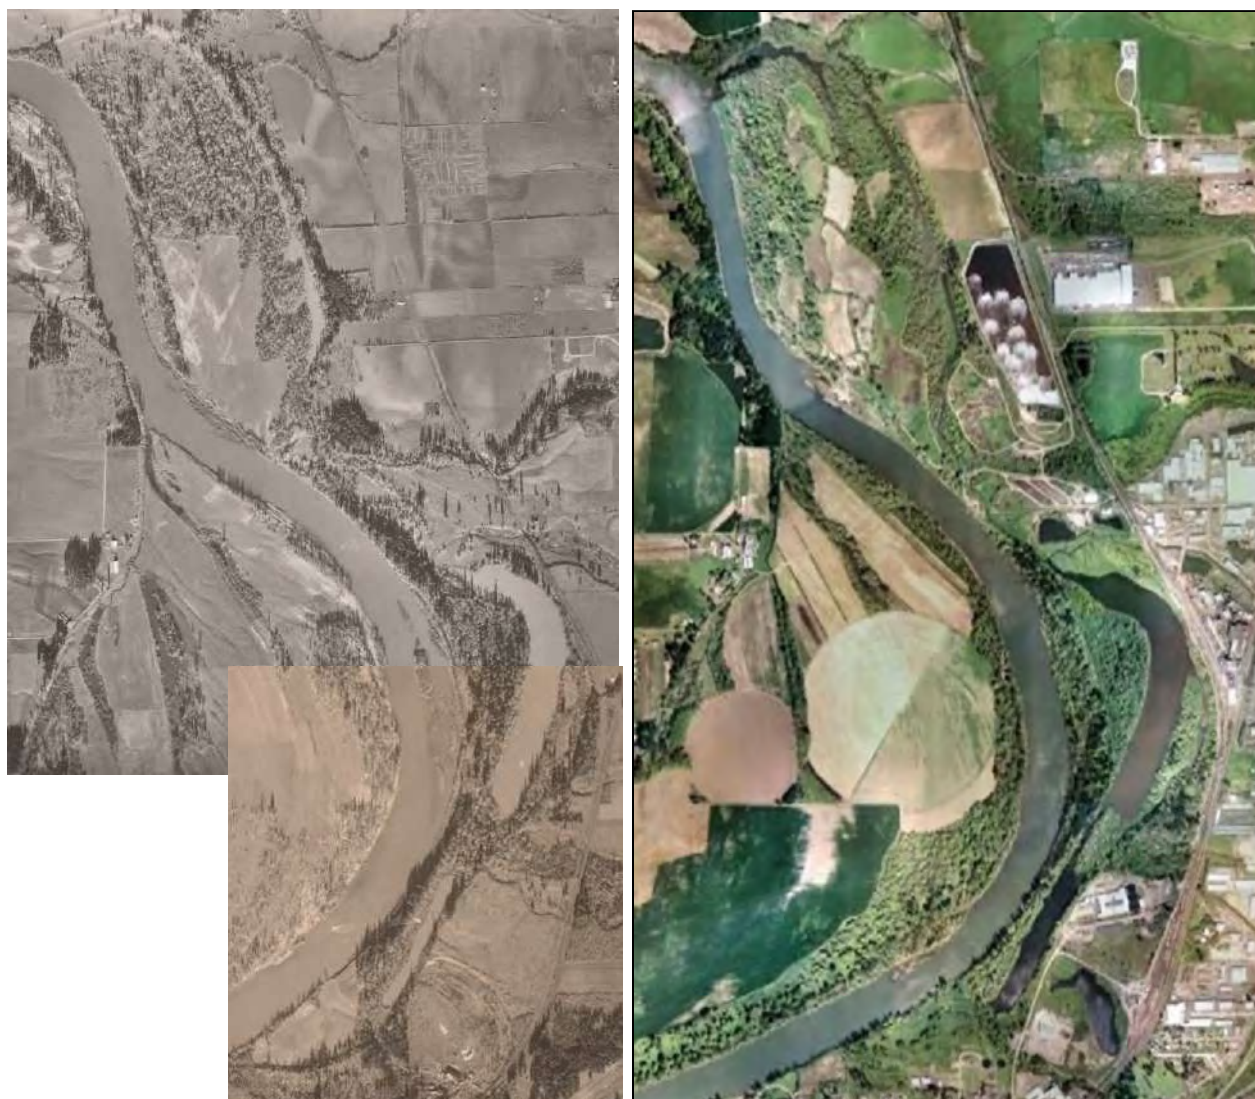
**Figure 4-34.** The 1936 (left) and 2006 (right) air photos of the Albany oxbow lakes area. The oxbow lakes area has been used for economic development since the 1800s when First Lake and Second Lake were used to store logs for the timber mills that have occupied the eastern floodplain of the Willamette River. The industrial wastewater treatment ponds that were most recently used by the International Paper facility were constructed between the 1950 and 1971 air photos.

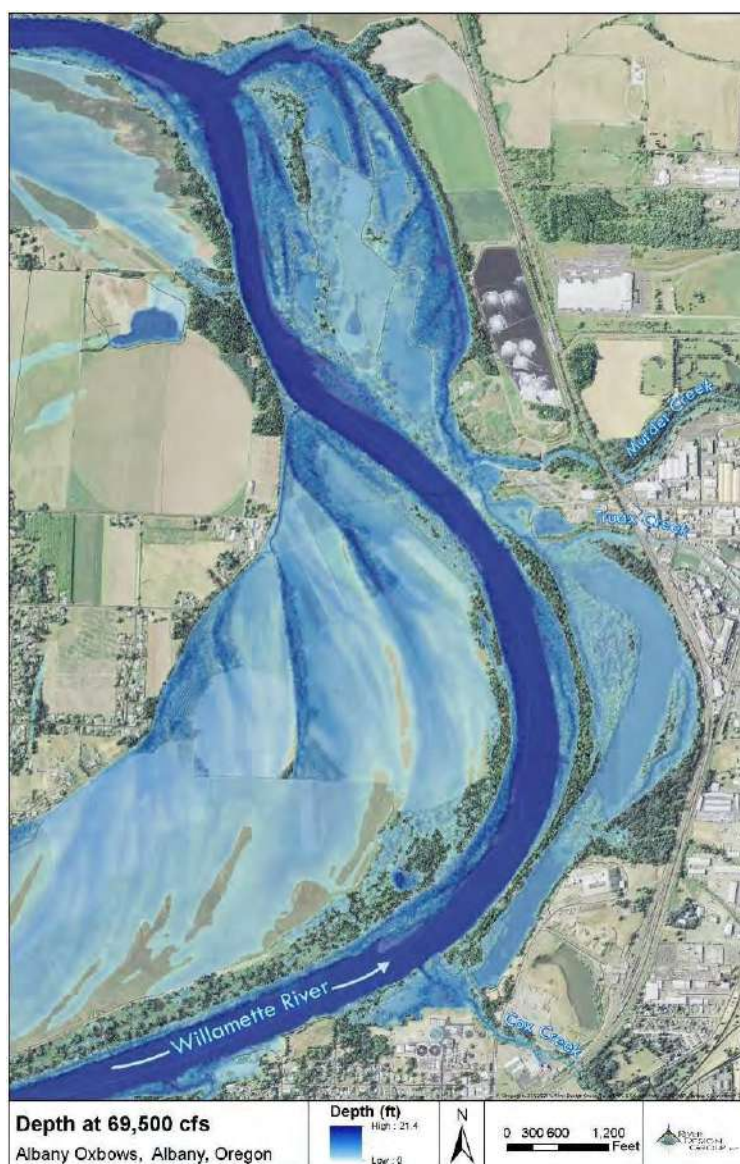
**Figure 4-35.** The predicted 2-year inundation map for the Willamette River including the Albany oxbow lakes and the North Albany floodplain. The Willamette River backwaters and overtops floodplain areas in the assessment reach.

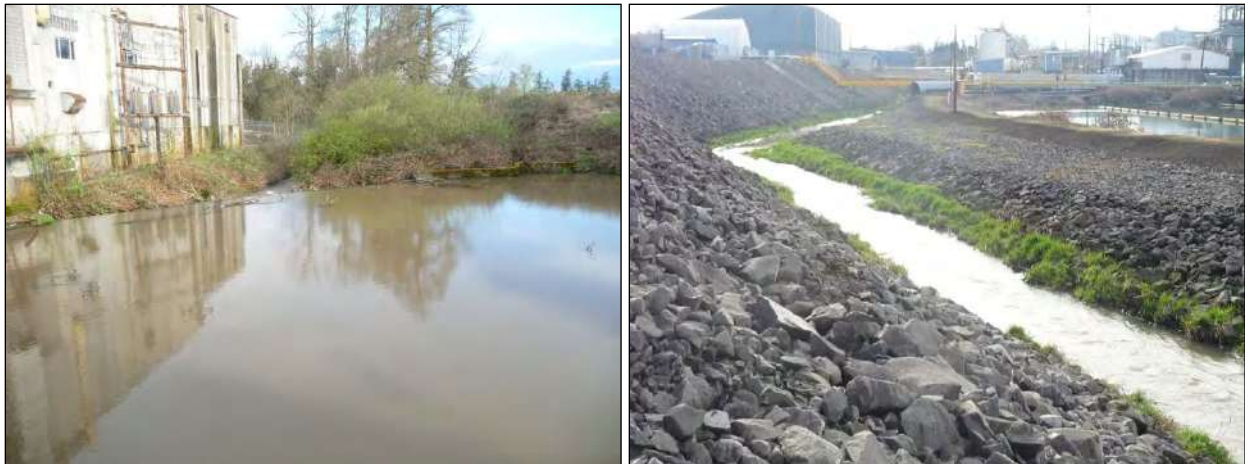
**Figure 4-36.** The concrete dam on lower Cox Creek is a fish passage barrier to upstream migration (left). Truax Creek was formerly used to dispose of industrial wastes. Contaminants were removed from the stream corridor and the creek was stabilized (right). Treated wastewater from the ATI-Wah Chang facility is discharged to Truax Creek, providing flow in lower Truax Creek after the upstream seasonal stream dewatering in the summer.

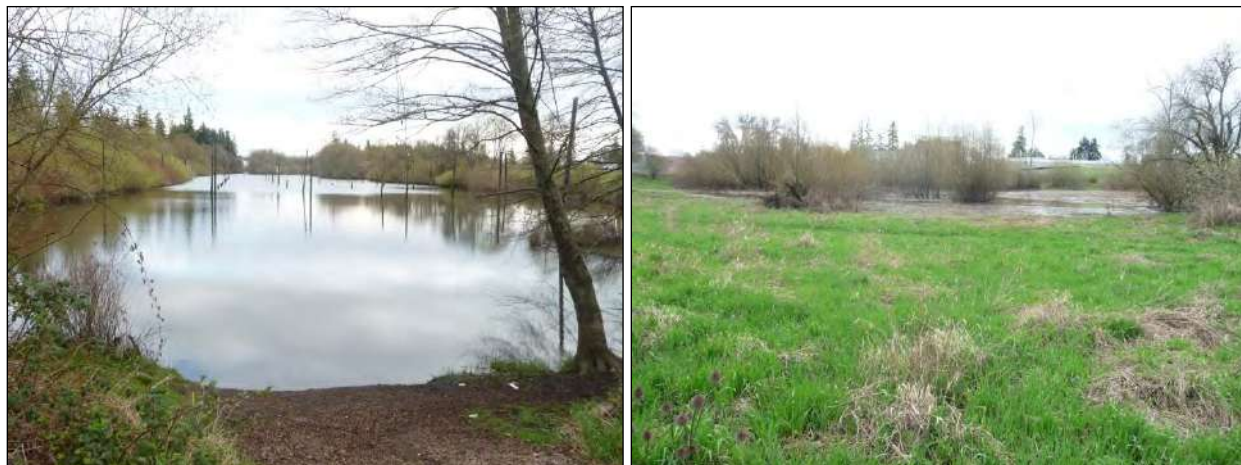
**Figure 4-37.** Timber piers in First Lake reflect the historical use of the oxbow as a log storage pond (left). The confluence area of Cox Creek and the Willamette River is characterized by a broad wet meadow that provides aquatic and riparian habitat (right).

First Lake and Second Lake were historically used as log ponds by the local mills. Pilings remaining in First Lake suggest the past use of the oxbow lake for storing logs that were then milled nearby. First Lake is shallower and smaller than the downstream Second Lake. A broad connector channel links First Lake and Second Lake. Riparian vegetation surrounding the lakes is characterized by native species with a surprising infrequency of invasive species that are

common elsewhere on the Willamette River floodplain. A road located to the west of the oxbow lakes separates the lakes from the Willamette River. The road has been converted to a walking path but still functions as a levee disconnecting Willamette River high water from the oxbow lakes. Figure 4-37 includes photos of First Lake and the lower Cox Creek floodplain.
