# Calapooia River - Albany Assessment and Project Implementation Plan

## Final Report

*Site Assessment on the Willamette River.*

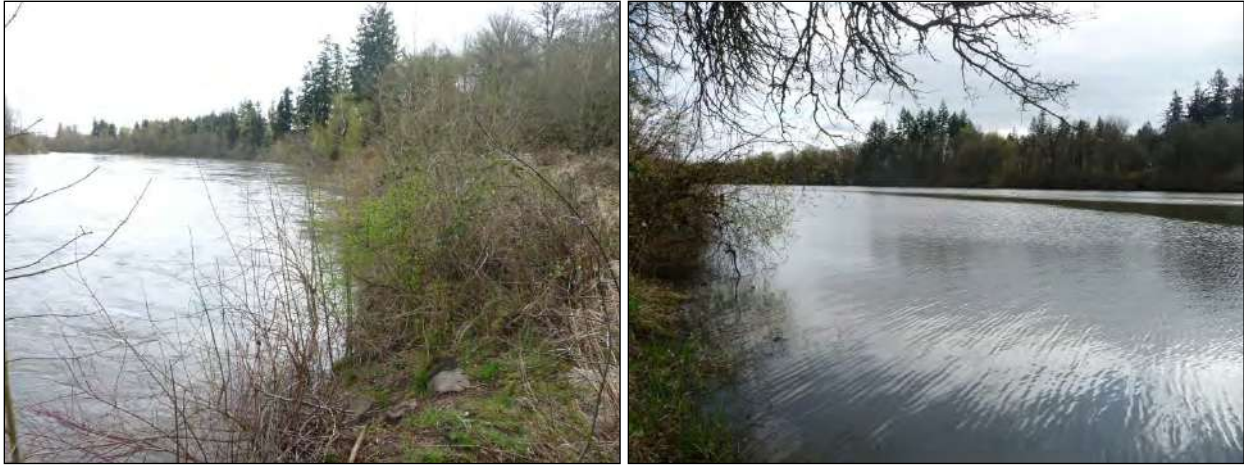
**Figure 4-38.** A view of the river-right bank of the Willamette River adjacent to the Albany oxbow lakes (left). The foreground of the photo shows remnant riprap that was placed for bank stabilization. The riparian corridor is characterized by a multistory plant community dominated by native species. A view across Second Lake illustrates the size of the oxbow lake and the complex riparian community (right).

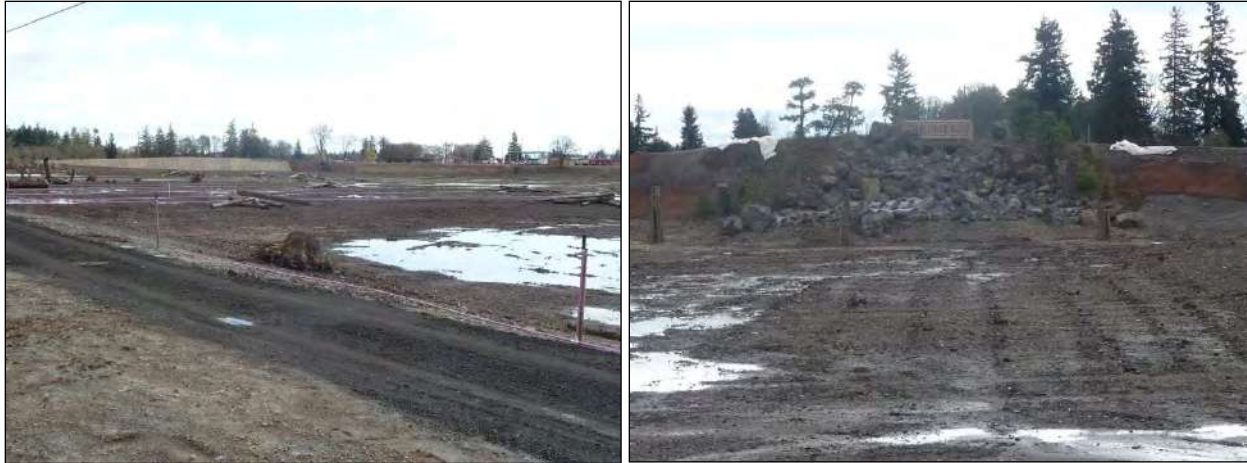
**Figure 4-39.** A view to the northeast across the Talking Water Gardens wetlands (left) and a view of one of the five aeration waterfalls planned for the site (right). The treatment wetlands will provide recreational and educational opportunities for the local community as well as cool and remove nutrients from treated wastewater.
