# **Calapooia Watershed Fish Passage Assessment**

**February 2004**

***BioSystems  
&  
Alsea Geospatial***

**For the  
The Calapooia Watershed Council**

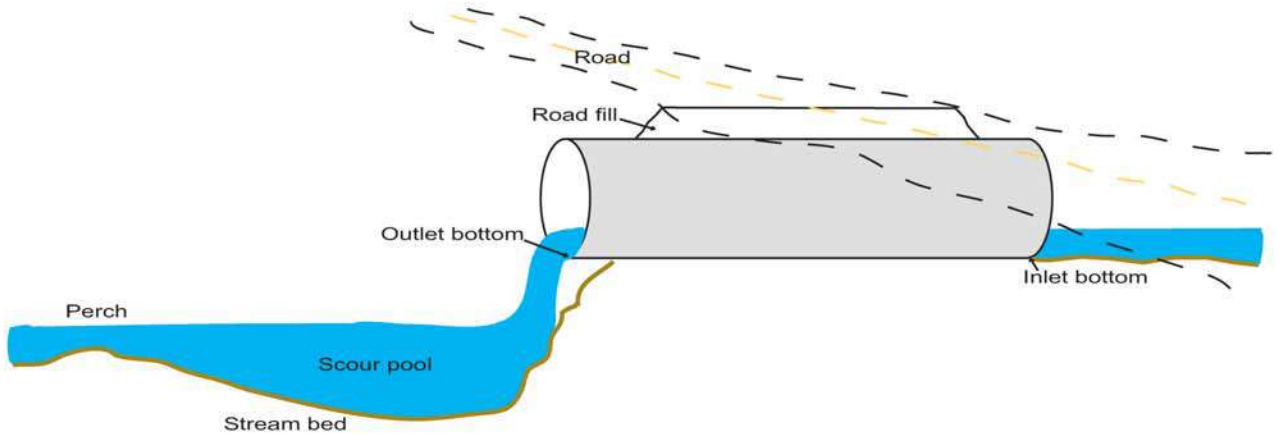
1a. Generalized cross section of culvert at road-stream crossing.

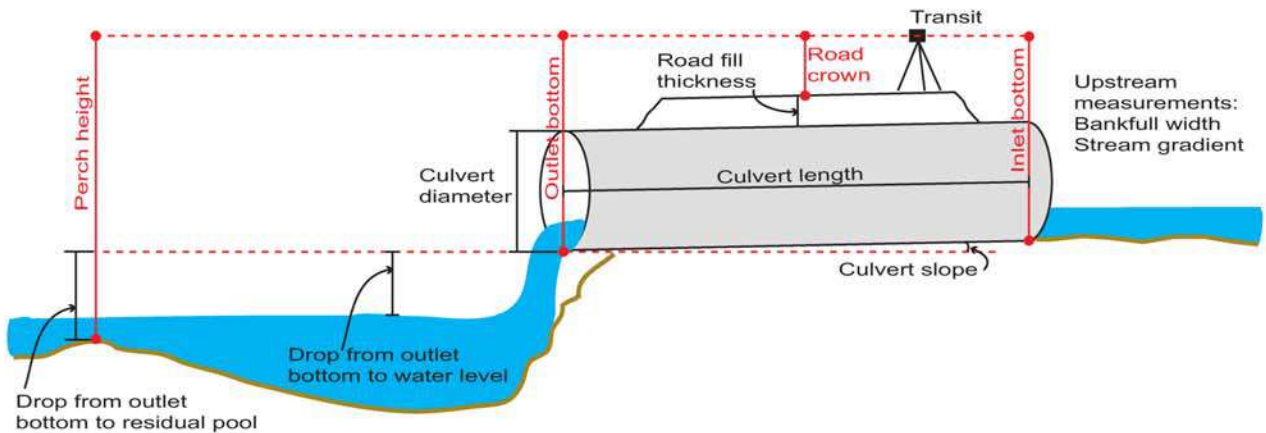
1b. Generalized dimensions of a culvert at a road-stream crossing. Transit measurements are shown in red, and other dimensions are shown in black.

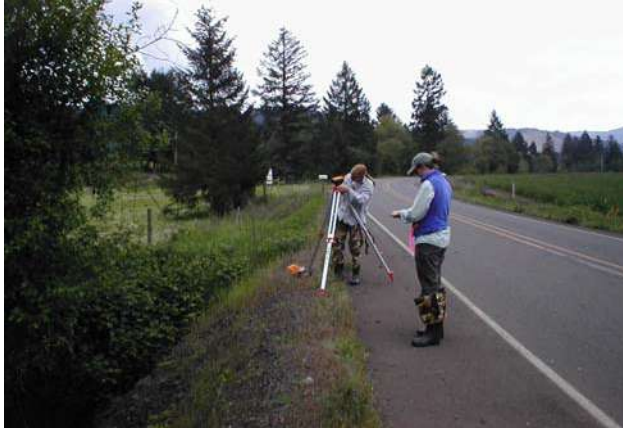
*Photo 3. Culvert 435B where Brush Creek Road crosses West Fork Brush Creek. Setting up the transit for the field survey and recording location information with the GPS.*

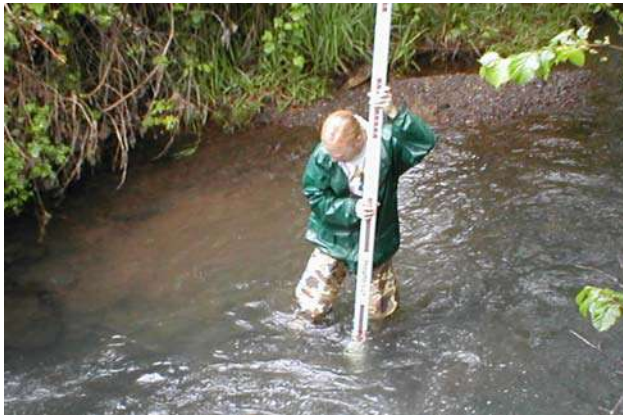
*Photo 4. Culvert 323 in the headwaters of Brush Creek. Below the culvert outlet collecting maximum scour pool depth measurements.*

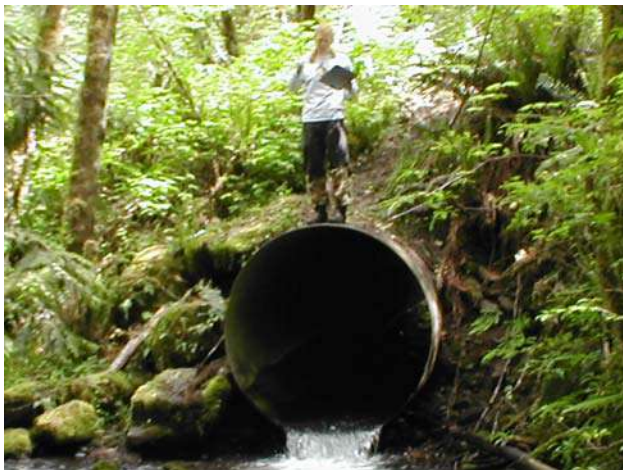
*Photo 5. Culvert BC1 in the headwaters of Brush Creek. Noting the conditions of the culvert outlet.*

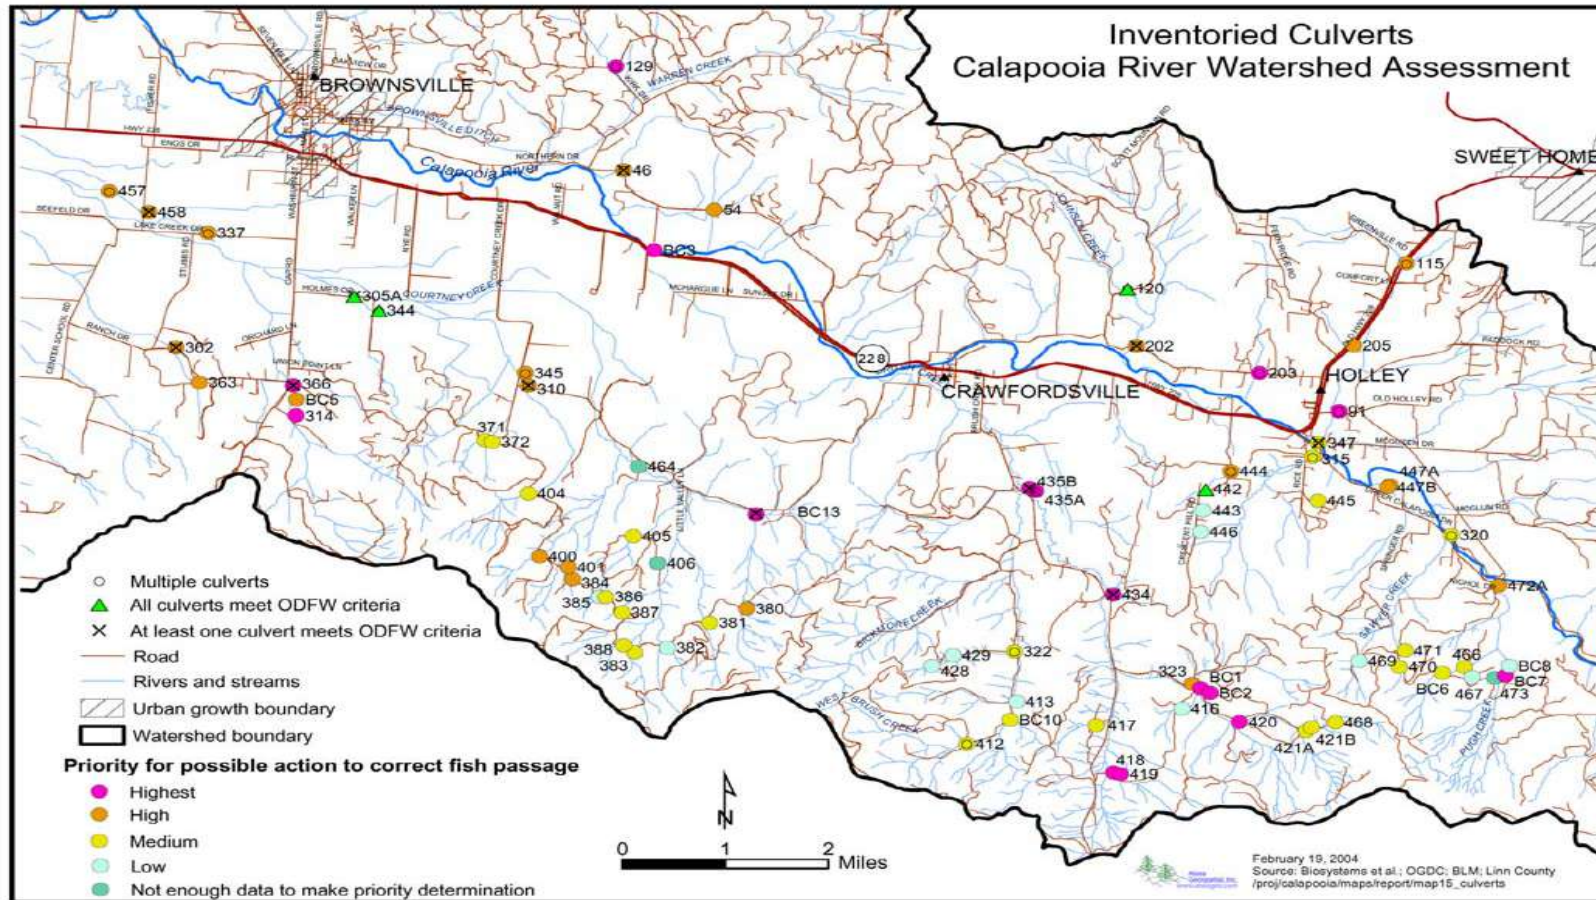
Figure 2. Map of the inventoried culverts and priority designations (bridge sites are not mapped).

Very few culverts in the inventoried area meet the ODFW criteria for juvenile fish passage. Out of a total of 80 culverts evaluated, 75 had outlet jump heights and/or gradients that did not meet the criteria. Of the culverts that did not meet the fish passage criteria, 16 had the highest priority rating; 23 had high priority ratings; 24 had medium ratings; and 12 culverts had low priority ratings. Highest and high priority culverts were found across all land uses and ownership categories: private, Linn County, and Bureau of Land Management. Figure 2 is a map of all of the inventoried culverts. Photos 6-11 provide examples of culverts with different priority ratings for addressing fish passage. Table 4 outlines the results of the evaluation, listing the priority ratings of culverts that did not meet ODFW criteria and bridge sites with fish passage problems. Many road crossings had more than one culvert in use (see Photos 6, 8 and 10), and each individual culvert was evaluated.

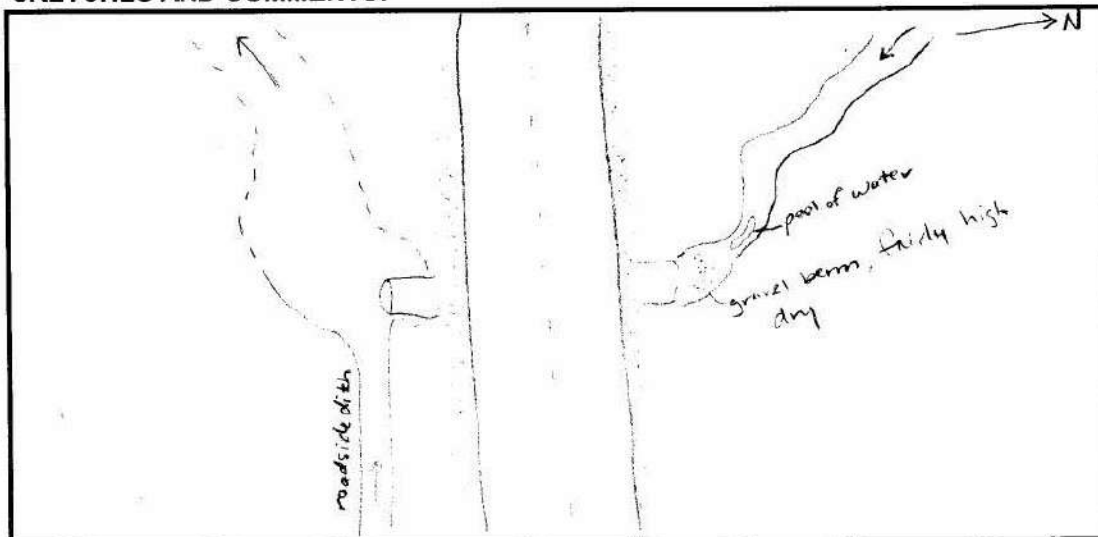
## SKETCHES AND COMMENTS:

Bottom of inlet (transit): 8.30'	% slope: /	Bankfull width: 7'	Upstream gradient (clinometer): 0.5 - 1%
Pictures: 115 Looking upstream at stream 116 Looking downstream at barrier
