Bowers Rock State Park Alternatives Analysis

Meyer Memorial Trust

RIVER
DESIGN
GROUP, INC.

September 29, 2014

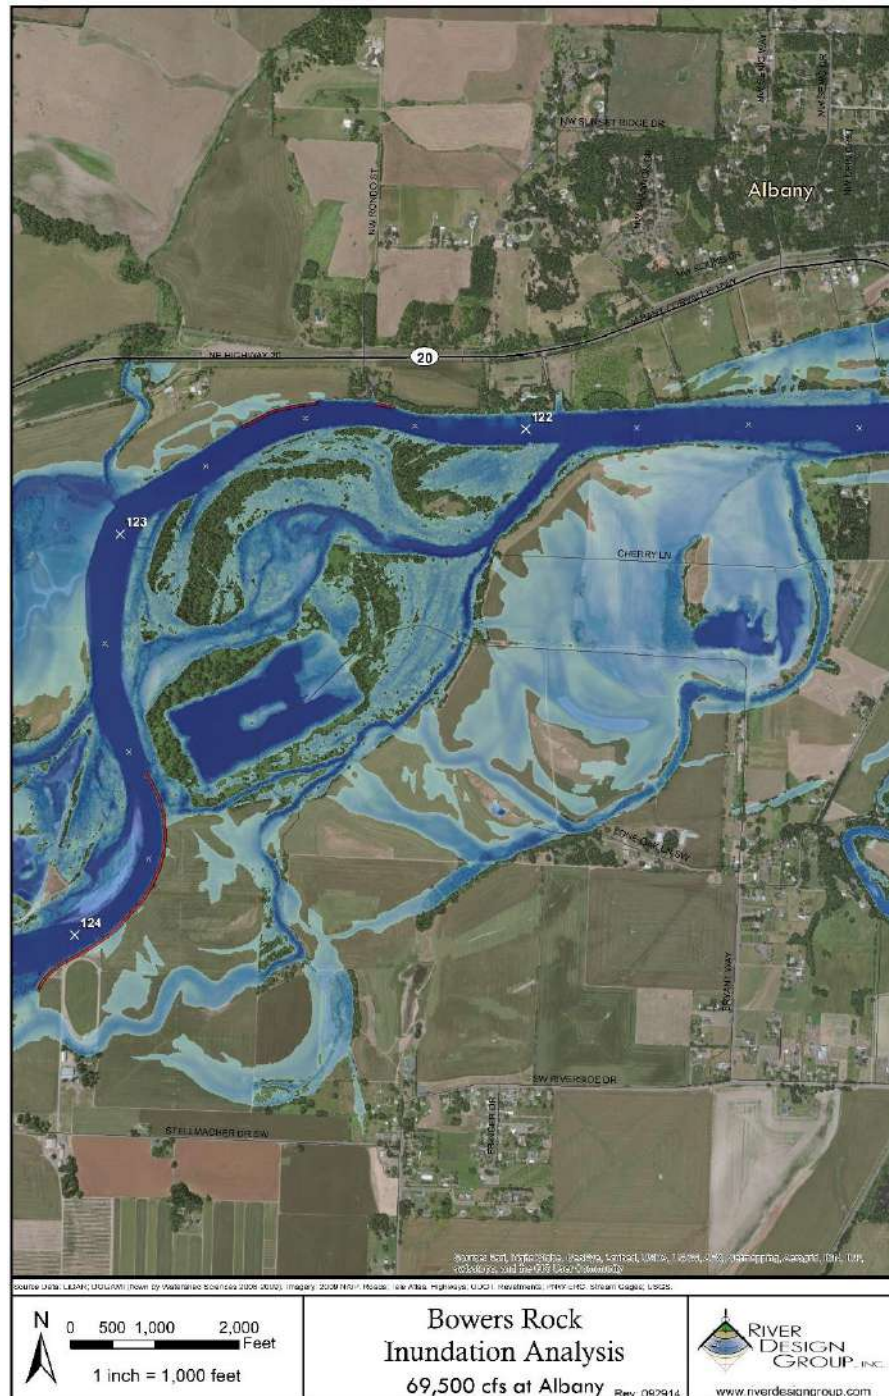
Figure 2-4. The 2-year flow inundation map prepared for BRSP. The modeled inundation level represents a discharge of 69,500 cfs as measured at the USGS gage at Albany, OR.

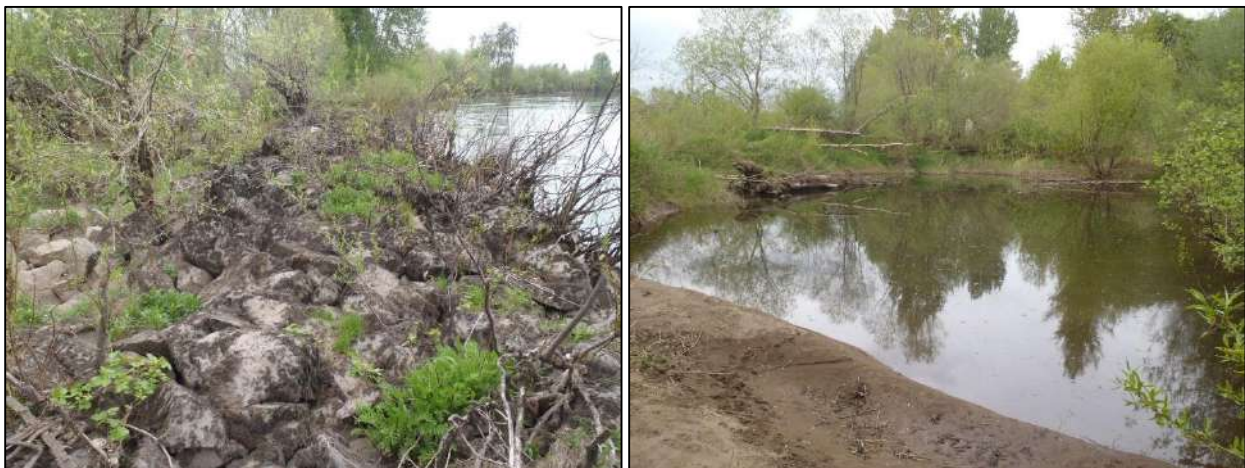
Figure 4-2. An upstream view of the Coon Creek revetment located on the river-right bank of the Willamette River to the west of BRSP (left). A pond located between the revetment and gravel pit pond (right).

In 1962, the U.S. Army Corps of Engineers completed the Coon Creek revetment (see Attachment B) on the river-right bank of the Willamette River adjacent to the future gravel pit. The revetment is a low elevation, 3,276 foot-long revetment that provides scour protection, but not flood protection. The revetment terminates west of the gravel pond's midpoint and is currently functioning as intended (Figure 4-2). Typical elevations for the revetment surface adjacent to the gravel pond range from 188.0 ft to 189.0 ft. A scoured pond located to the east of the revetment was present in the 1967 air photo and may be maintained by flows that overtop the revetment (see Figure 4-2).

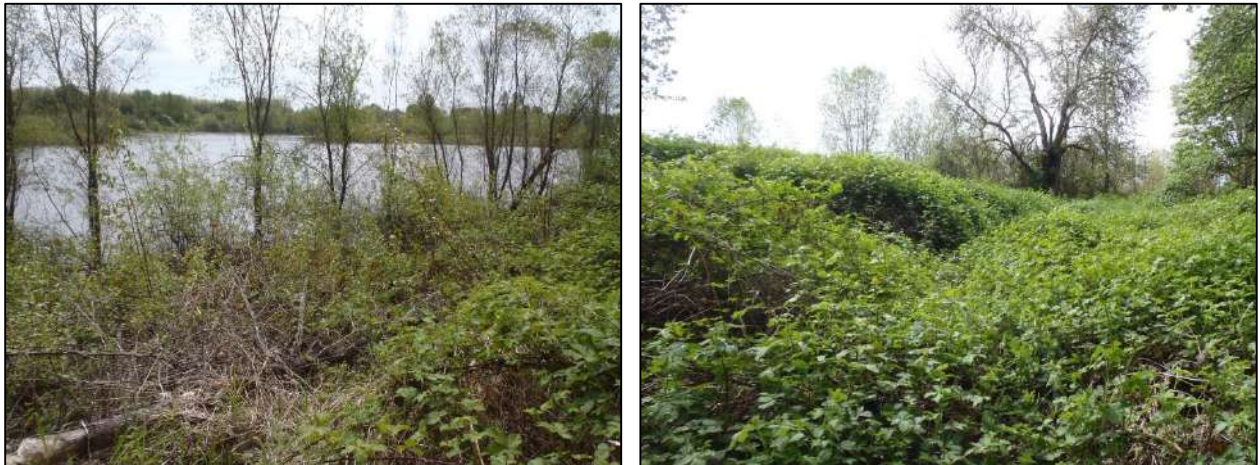
Figure 4-4. A view of the gravel pit pond from the northeast pond margin looking to the west (left). The photo shows the transition from blackberry at the excavated slope to willows at the pond edge. The right photo shows the typical dense blackberry cover on historical haul roads located adjacent to the pond.

Mature maple, ash, and cottonwood trees are located on surfaces outside of the historical disturbance footprint and indicate the extent of the gravel mining operation. Figure 4-4 includes representative ground photos of the gravel pit pond and adjacent disturbed ground surfaces.

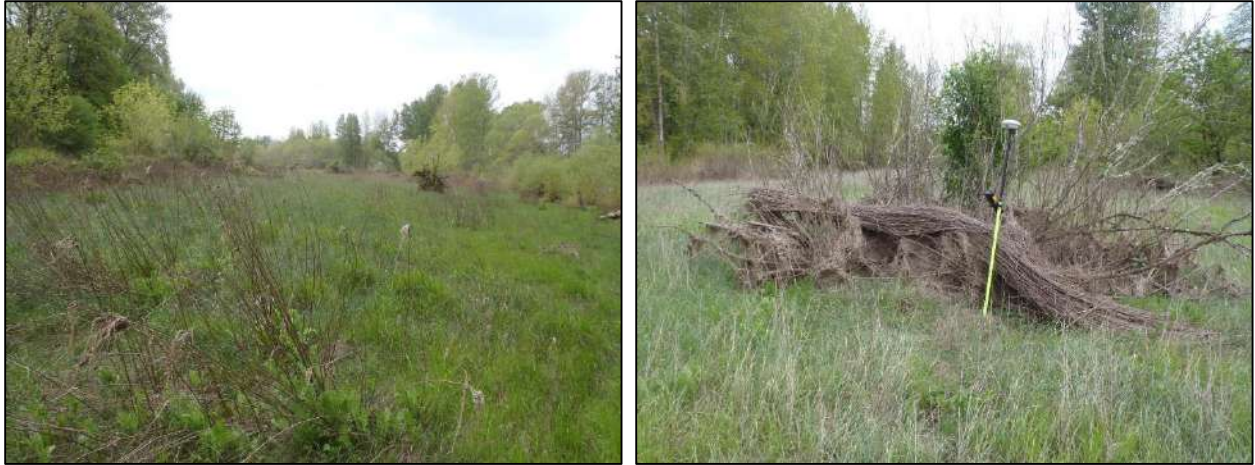
Figure 4-5. An upstream view of the upstream extent of the Coon Creek channel showing the broad floodplain channel morphology (left). A debris raft collected on a riparian shrub in the Coon Creek channel suggests the height of recent floodwater (right).

The upstream extent of Coon Creek is a broad floodplain channel north of the BRSP gravel pond. Coon Creek was historically active at relatively low flows. Based on RDG's remote sensing analysis, the Willamette River inundates this surface at approximately 23,500 cfs. This channel continues to provide high quality floodplain habitat although it no longer functions as frequently as it did historically due to river regulation and reduced flood magnitudes. The fine sediment that has filled the channel could be a fill material source for modifying the BRSP pond. Removing sediment from the channel would improve function, habitat condition, and provide a nearby fill material source for the BRSP pond. Figure 4-5 includes representative photos of the upstream Coon Creek channel.

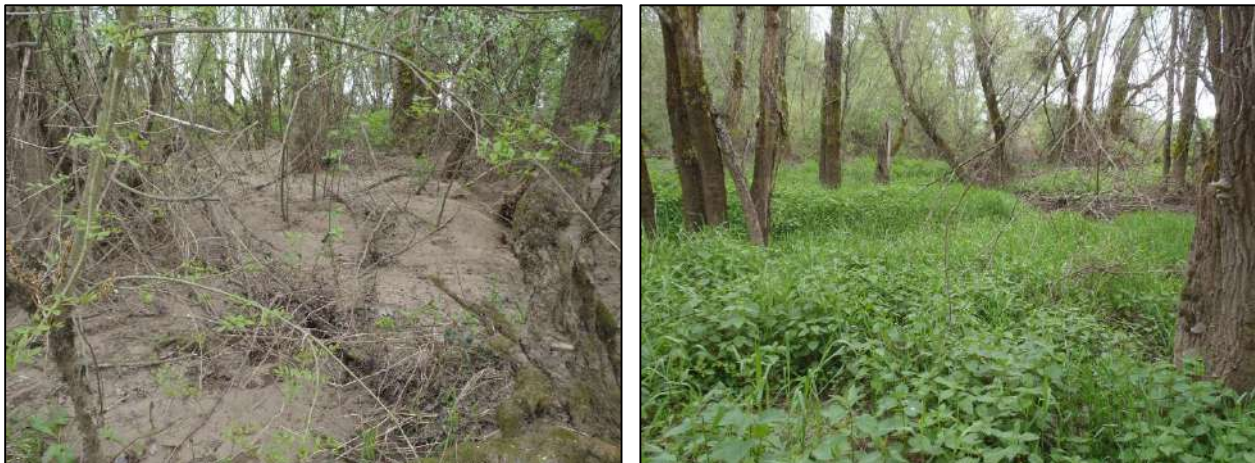
Figure 4-6. The low elevation floodplain between the Willamette River and the BRSP gravel pit pond is characterized by scour ponds and channels that route water throughout the area, and dense riparian vegetation. Extensive sand deposits suggest the relatively frequent inundation of the near-bank floodplain.

The eastern bank of the Willamette River between the river and the BRSP gravel pit pond is a dynamic area with large wood accumulations, scoured channels, and dense riparian vegetation. The Coon Creek revetment maintains the eastern bank line of the Willamette River, but allows overtopping flows that access the narrow floodplain between the revetment and the BRSP gravel pit pond perimeter. Scoured channels trend to both the north and south leading to the broad northern floodplain channel and the West Arm of the Little Willamette River, respectively. These channels could be used to route flow into the BRSP gravel pit pond as part of a restoration strategy. Figure 4-6 includes ground photos of the floodplain between the Willamette River and the BRSP gravel pit pond.

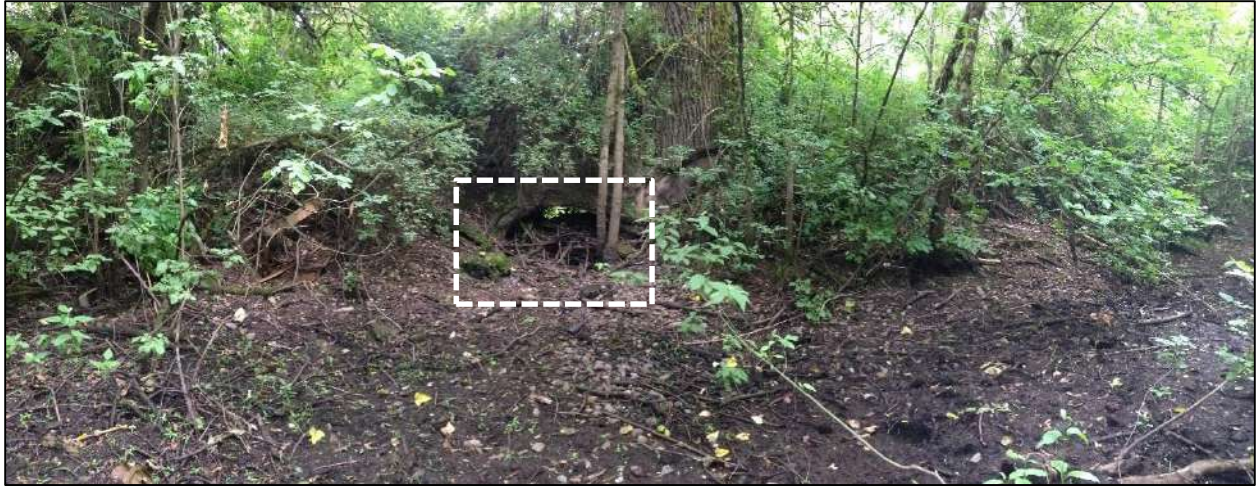
Figure 4-7. An upstream view of the culvert (white box) at ES-1. The mature cottonwood is located to the right of the culvert.

The ES-1 crossing is the primary road access into BRSP from Bryant Way. Access to the crossing is by way of a dead end road that terminates at the OPRD gate in front of the Huber residence. The crossing is an earthen fill with an unimproved surface. An existing 6 ft culvert provides conveyance through the earthen fill (Figure 4-7). Although the culvert provides a channel connection through the road crossing, the culvert is periodically affected by beaver dams, debris, and sediment deposition. Due to current stagnant conditions, poor water quality (e.g., depressed oxygen concentrations due to decaying vegetation) may affect fish inhabiting the East Slough).

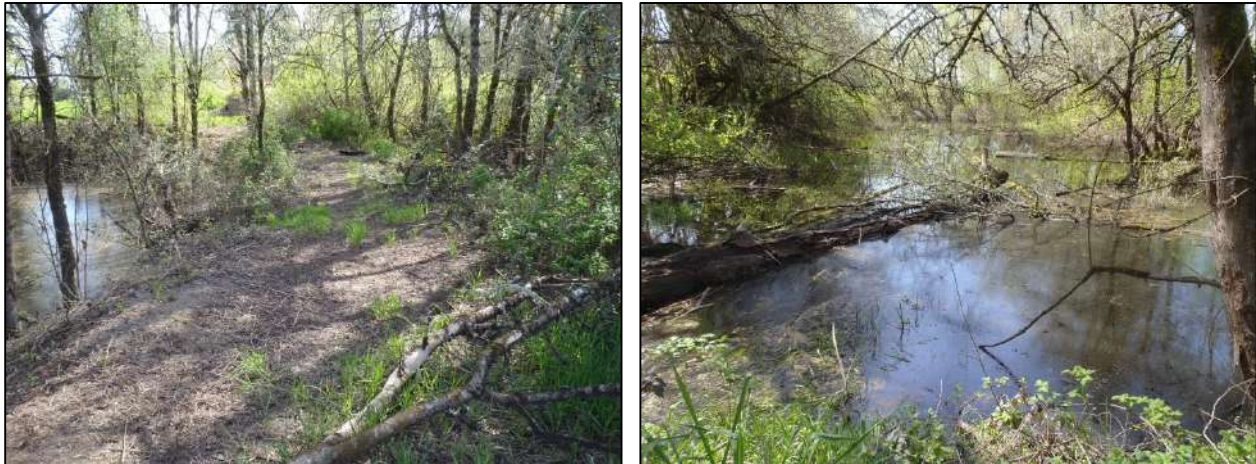
Figure 4-8. A view to the east across the ES-2 crossing (left) and upstream of the ES-2 crossing (right).

ES-2 is a secondary crossing on the East Slough. The crossing is an earthen fill with an unimproved surface (Figure 4-8). The crossing is mainly used to access the northeastern field adjacent to the East Slough. The narrow crossing primarily supports 4-wheel all-terrain vehicles (ATVs) and is too narrow for larger farm equipment to safely pass. Similar to ES-1, slough conditions upstream of the crossing may be affected by stagnant water related to the insufficient conveyance capacity and the elevation of the existing concrete box culvert.

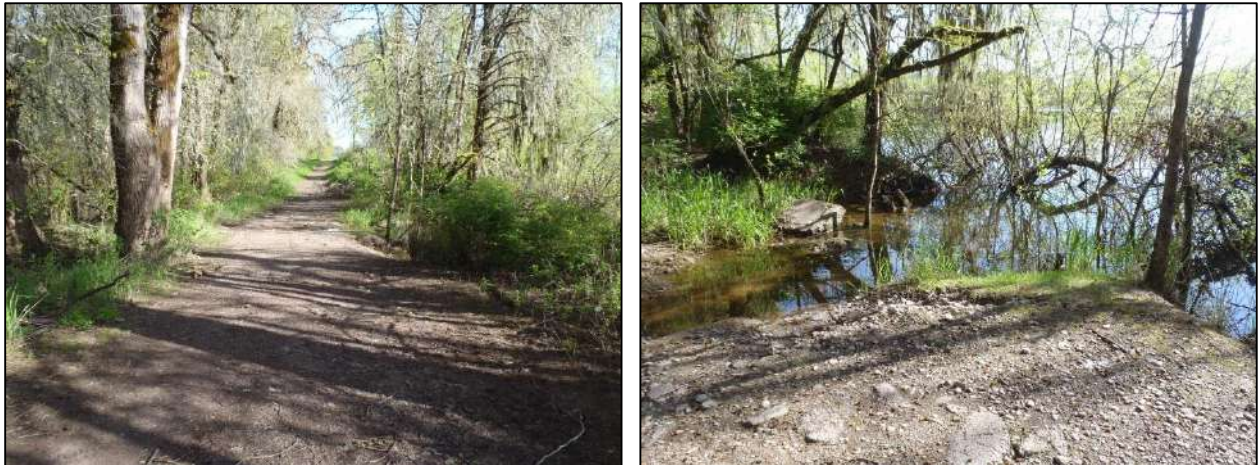
Figure 4-9. A view to the north of the WS-1 crossing (left), and a view of the low flow channel outlet from the OPRD pond (right).

pond connected the pond with the downstream flooded forest. The north-south oriented ford allows access to the east-west running road on OPRD property adjacent to the Scheler property and provides access to the Little Willamette River shared crossing. The road is suitable for passenger vehicles, farming machinery, and off-road construction equipment.

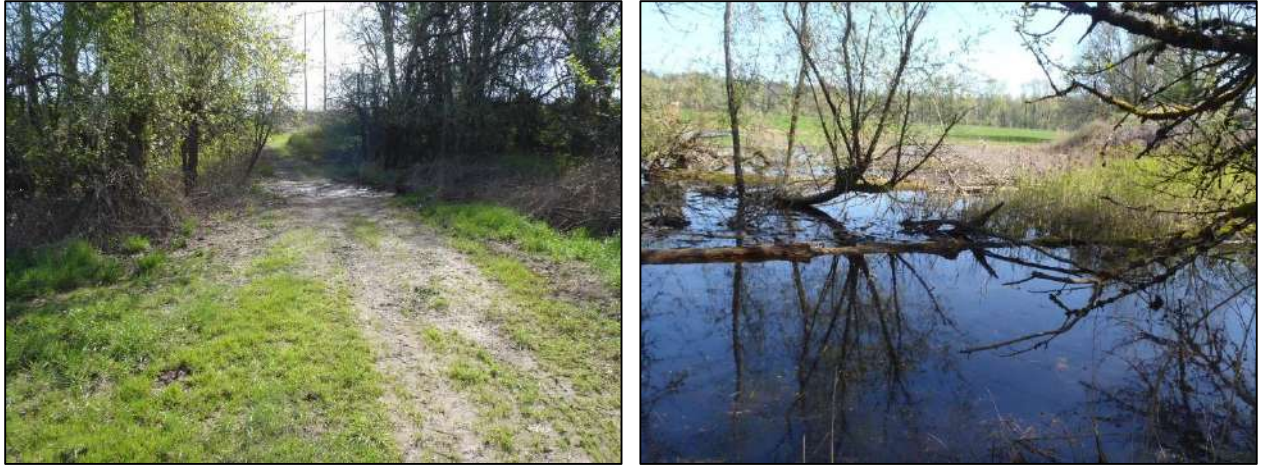
Figure 4-10. A view to the north across WS-2 (left). The right photo is a view downstream from the crossing showing the flooded forest stand conditions and the transition to the confined West Slough.

WS-2 is located on the West Slough in the downstream portion of the flooded forest stand. The crossing is a shallow earthen fill with an unimproved surface (Figure 4-10). Historically, this crossing was part of an east-west road that linked the primary site access (ES-1) with the west side of the property. The main portion of the road is believed to have been removed in the middle to late 2000s in order to farm the area occupied by the former road. Based on the crossing size and poor condition, the crossing looks to be mainly used by ATVs. The existing 18 inch corrugated plastic pipe is covered by minimal fill and the water surface elevation was close to the road surface at the time of survey. Similar to the East Slough, the West Slough is influenced by back water conditions created by downstream channel roughness. The crossing likely regularly overtops during winter high flows.

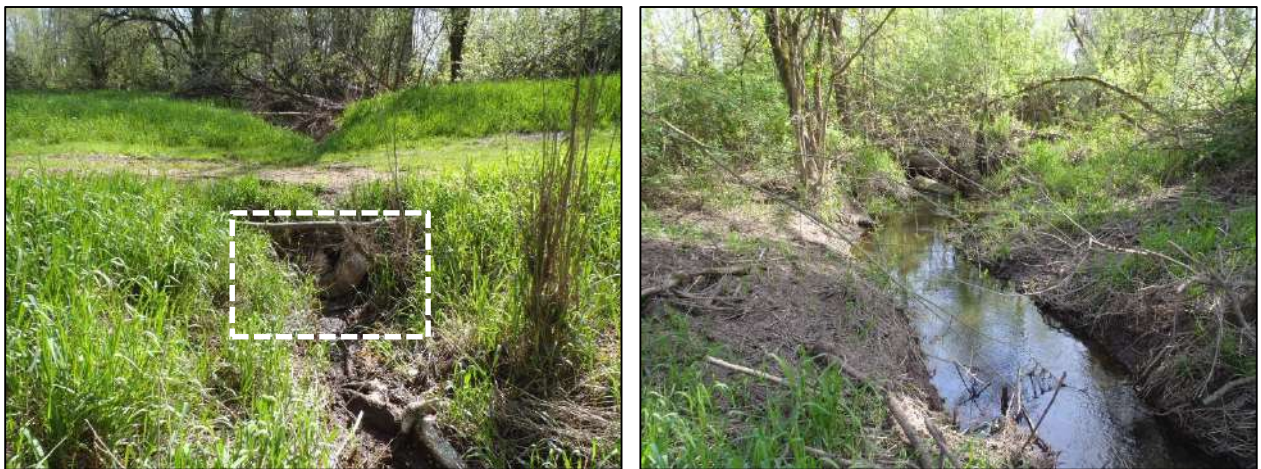
Figure 4-11. A downstream view of WS-3 (left) showing the minimal road fill over the culvert (white box), and a downstream view in the West Slough towards the East Slough-East Slough confluence (right).

WS-3 is a secondary crossing on the West Slough immediately upstream of the East Slough-West Slough confluence. The crossing is an earthen fill with an unimproved surface (Figure 4-11). Based on the crossing size and poor condition, the crossing looks to be mainly used by ATVs. The existing pipe includes a damaged corrugated metal pipe on the upstream end and a clay pipe on the downstream end of the crossing. The pipe looks to be frequently overtopped but the damaged upstream side of the pipe likely limits fish passage.

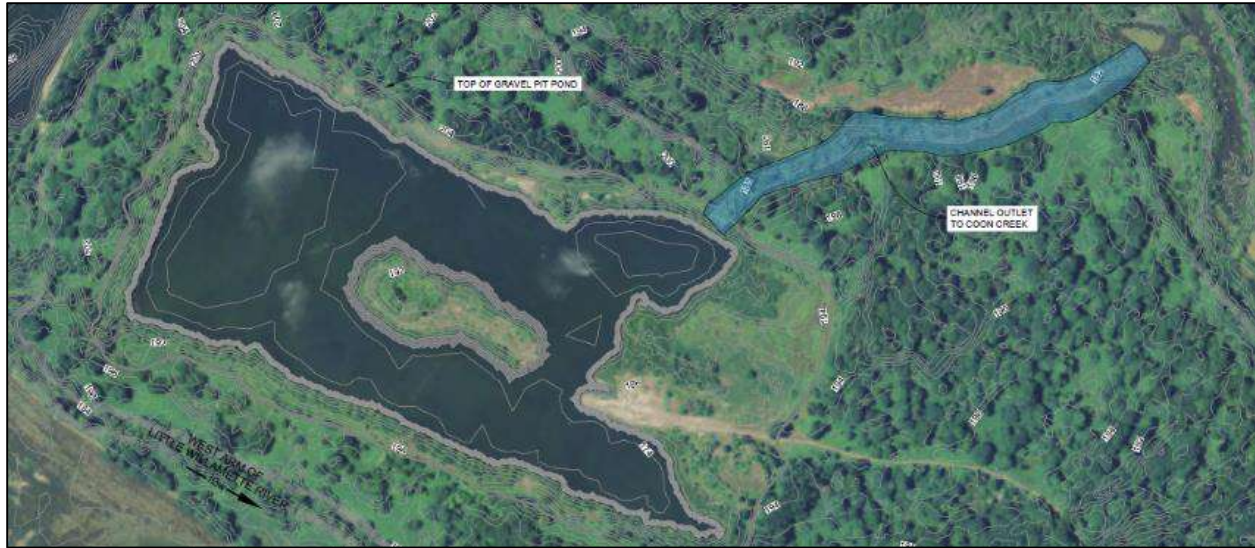
Figure 5-1. An aerial image of the BRSP gravel pond with the Alternative 1 – Channel Outlet highlighted. Alternative 1 includes excavating a connector channel between the gravel pond and Coon Creek.

The alternative would include constructing 1,550 ft of channel to connect the pond to the perennial portion of Coon Creek. The approximately 12,000 cy of excavated floodplain soils would be placed in the gravel pond margins to modify the pond shape. Of the three action alternatives, Alternative 1 has the lowest project cost, stability risk, and ecological benefit. The estimated project implementation cost is \$315,000.

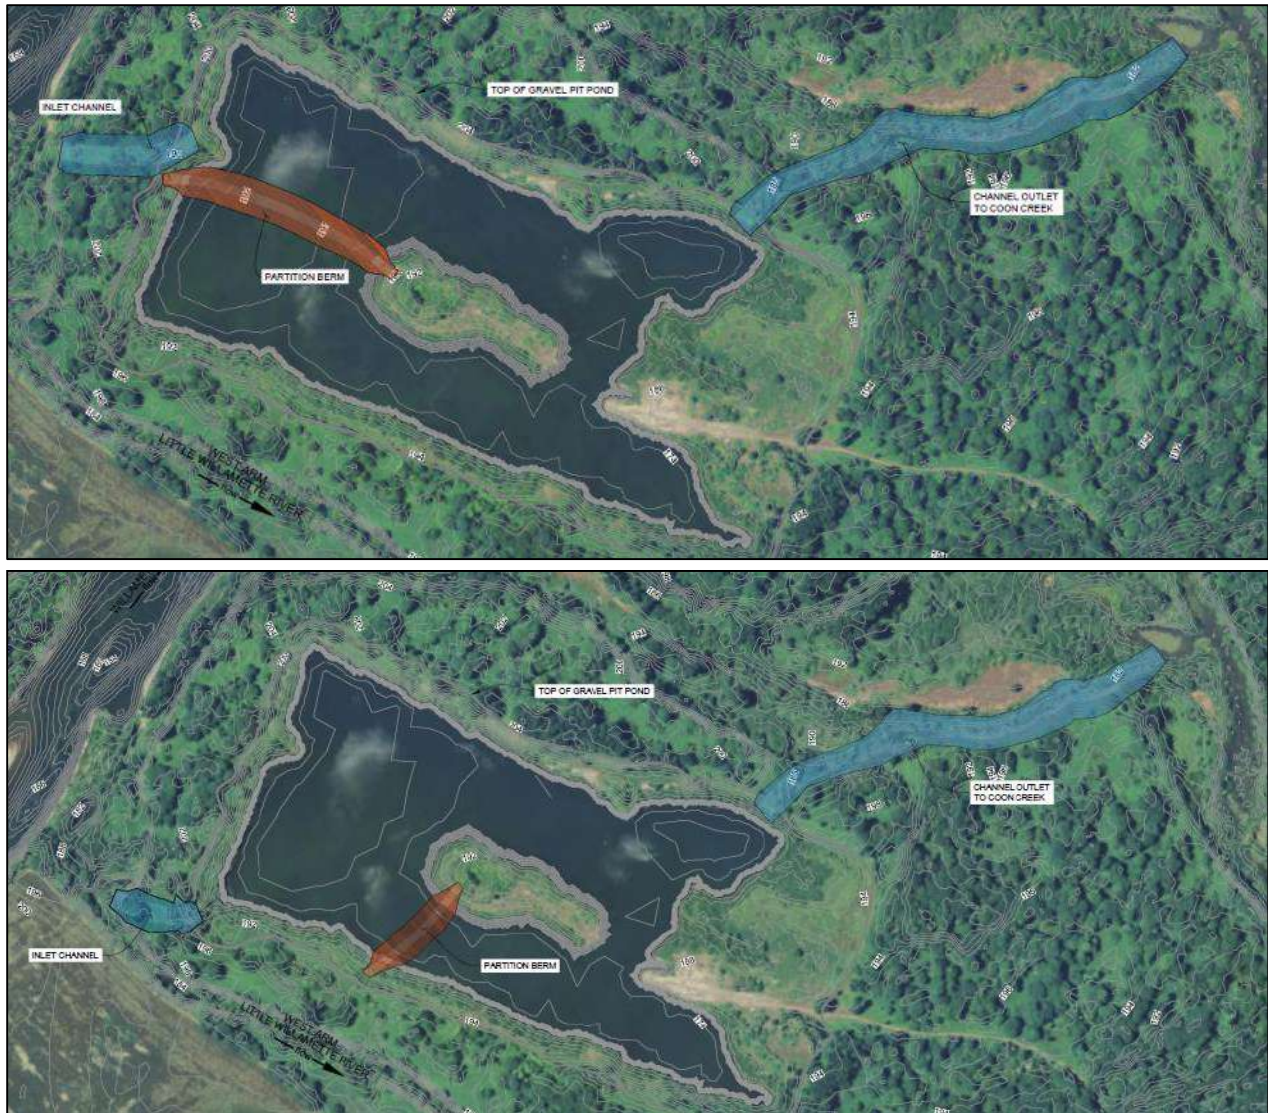
Figure 5-2. An aerial image of the BRSP gravel pond with Alternative 2A (top) and Alternative 2B (bottom) highlighted. Alternative 2 includes excavating inlet and outlet connector channels and an interior partition berm to reduce the effective flow-through area to promote native fish habitat. The sub-alternatives vary according to the inlet channel and partition berm locations.

Of the three action alternatives, Alternative 2 has a moderate project cost, stability risk, and ecological benefit. The estimated project implementation cost for Alternative 2A and Alternative 2B is \$592,000 and \$545,000, respectively.

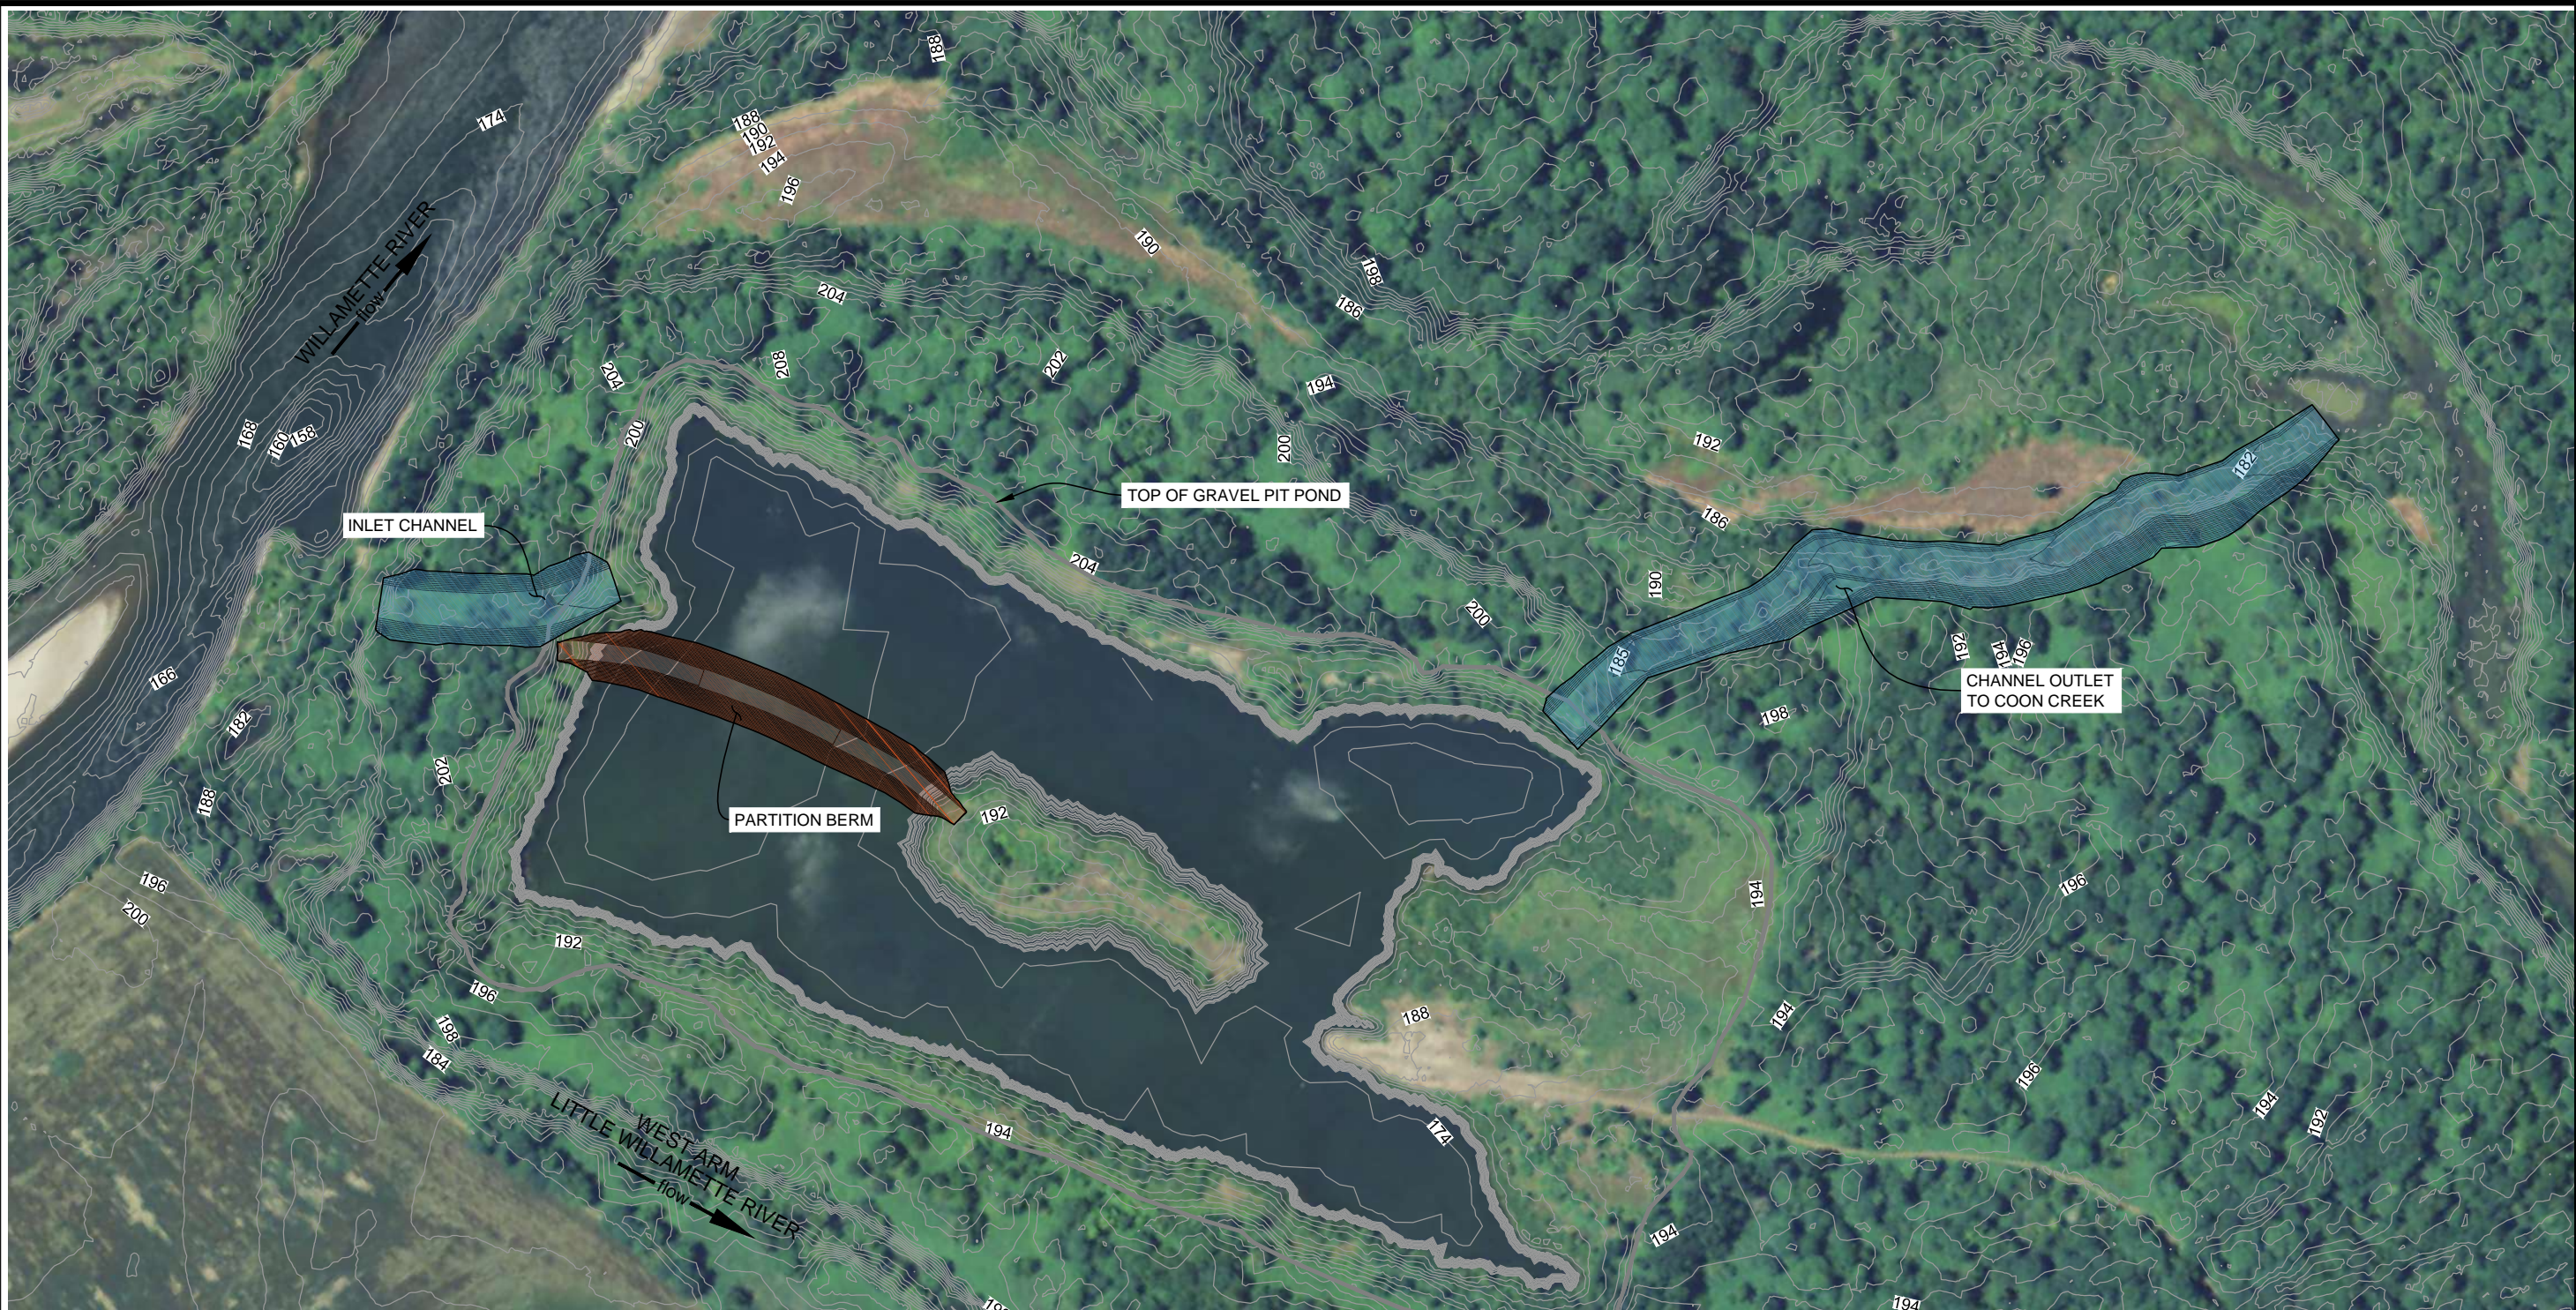
1 ALTERNATIVE 2A: FLOW-THROUGH CONNECTION

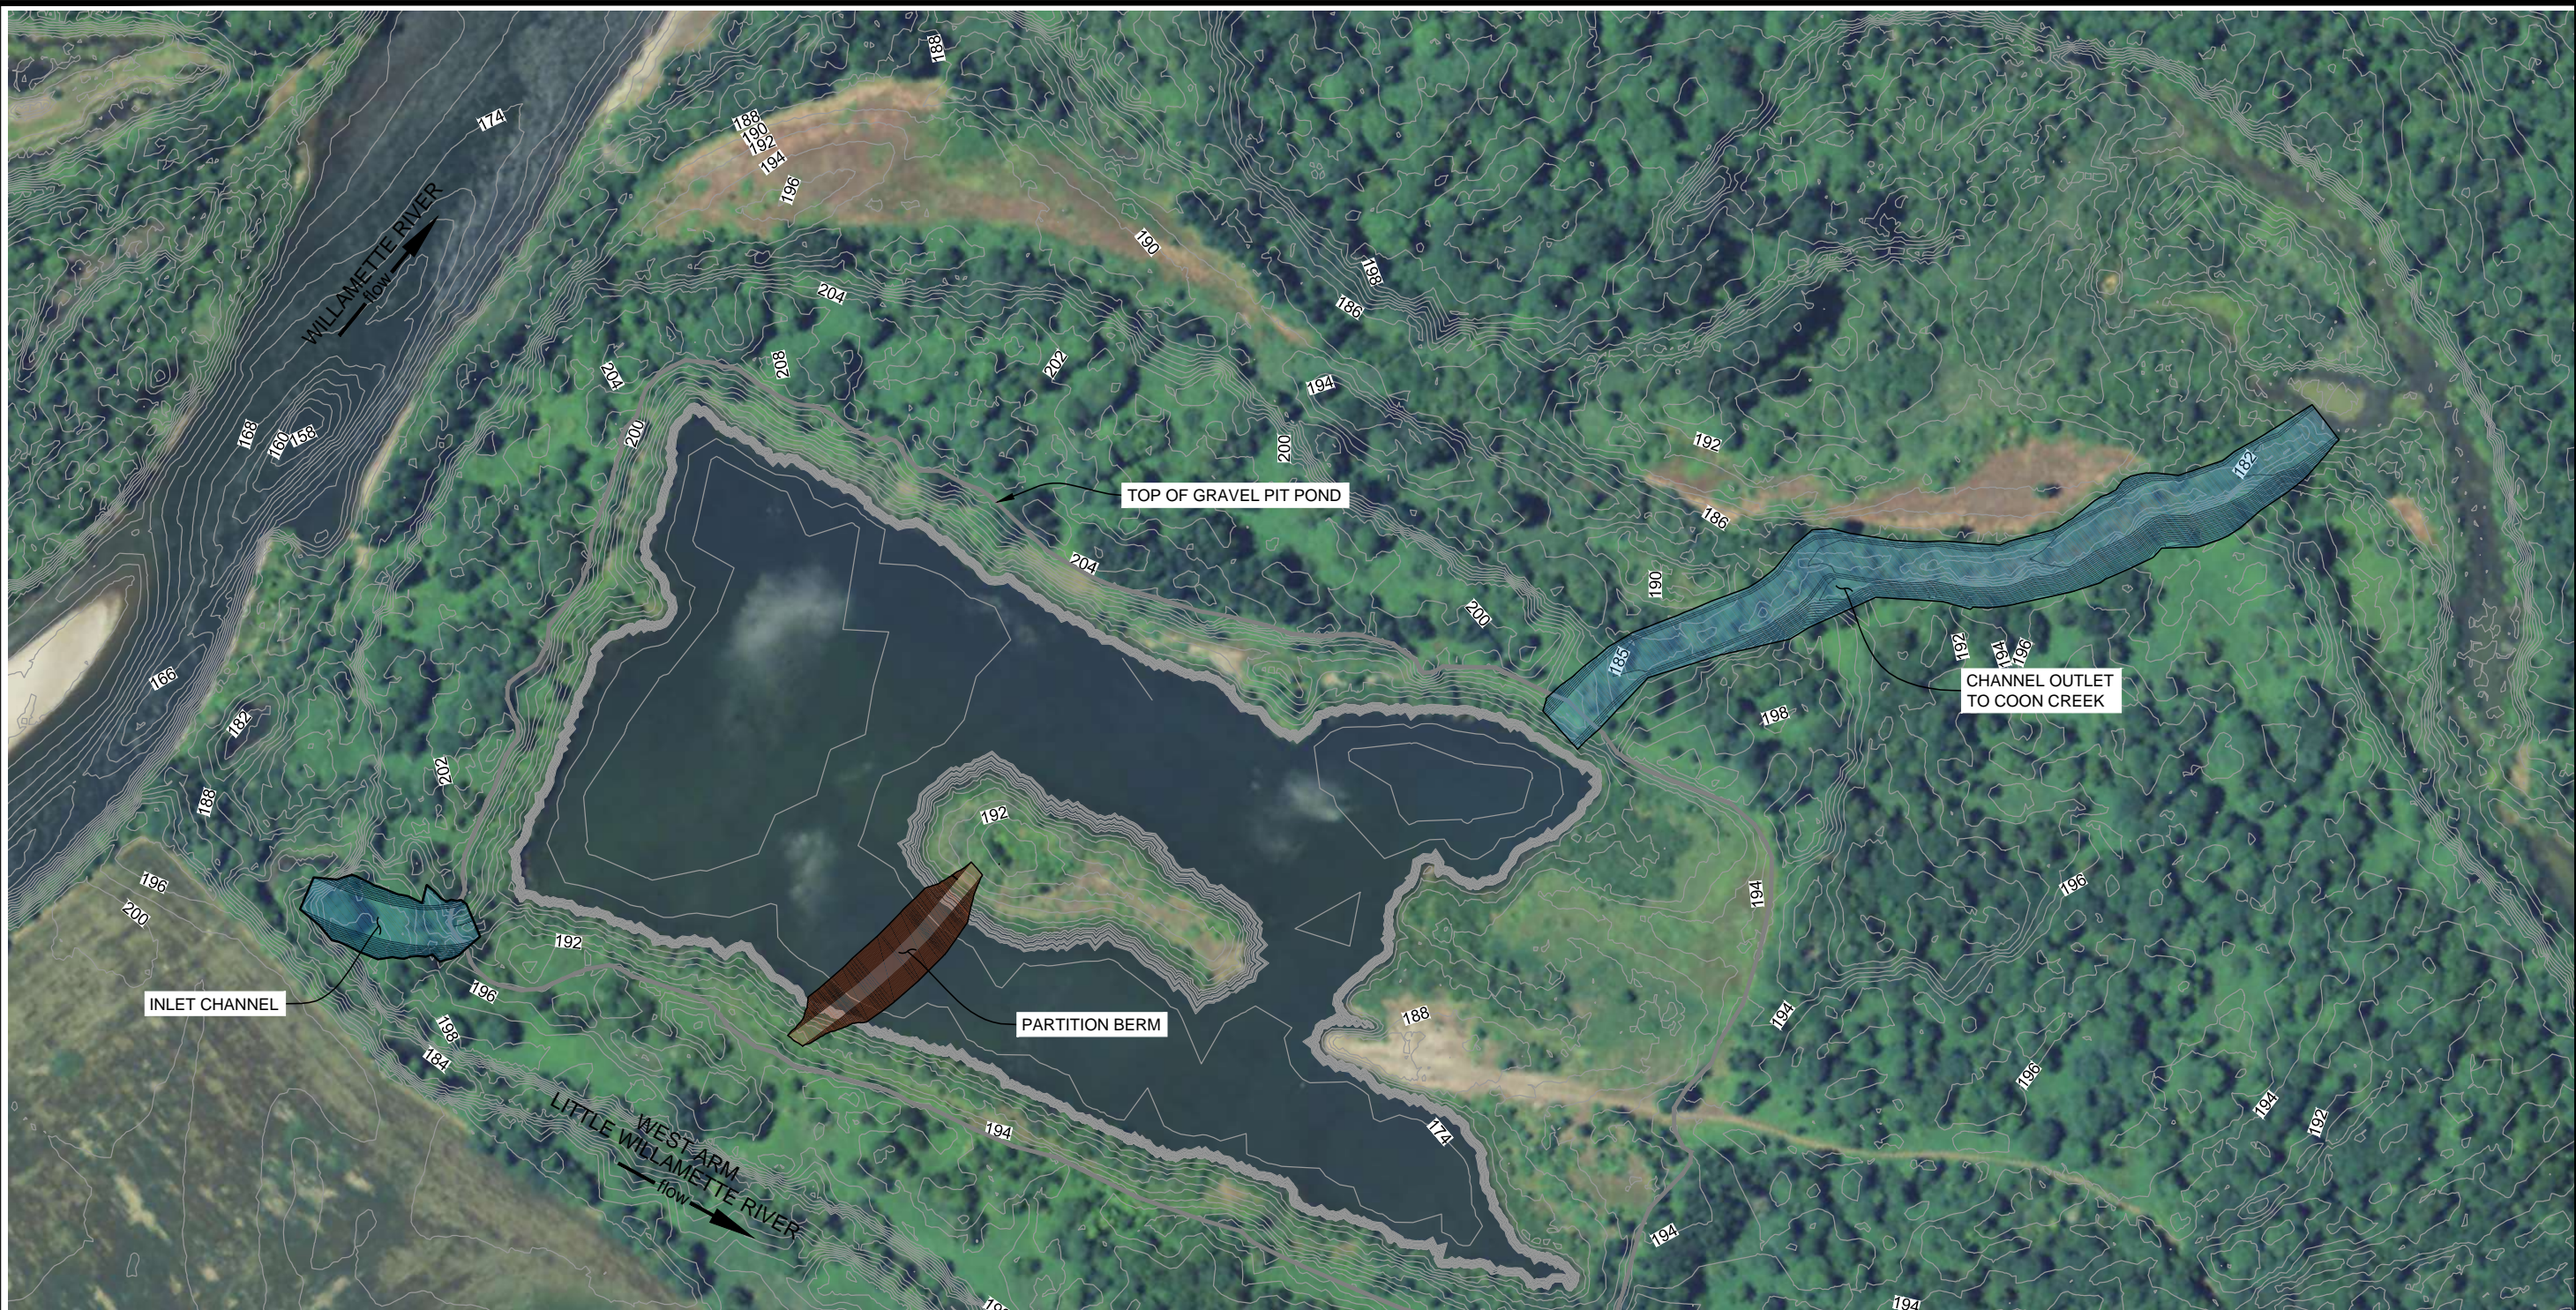
1 ALTERNATIVE 2B: FLOW-THROUGH CONNECTION
